Thor Motor Coach Recall Repair Instructions

Recall #	23v-759 & 2023-621		
Description/Title:	Rize and Scope Solar Panels		
Affected Product Line(s):	Certain model year 2021 – 2024 Rize and Scope motorhomes		
Service Campaign # :	RC000298	Released Date:	1/10/2024
Repair Code:	Inspect: TMCRC80511Y Repair: TMCRC80511V	Document Date:	1/9/2024
Time Allowed:	Inspection .2 Repair .5	Document Revision:	A

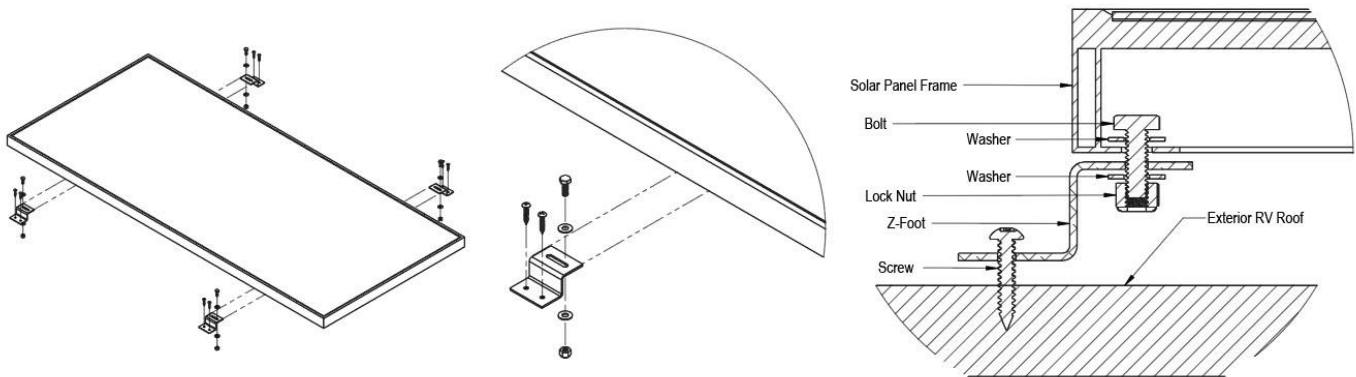
FIGURE 4-A: SOLAR PANEL INSTALLATION DETAILS

It has been discovered that on certain model year 2021 – 2024 Rize and Scope motorhomes that the solar panel mounts may fracture. The hardware used to mount the solar panel to the roof brackets may be missing the washers on the bolts at each of the four brackets.

1. If the aluminum frame does not show signs of fracture, two washers are to be installed at each of the four brackets as shown in Fig. 4-A
2. If the solar panel does show signs of fracture, replace the panel, as well as add the washers to the hardware. You will need to determine if you have a 190 watt or 200 watt solar panel and order through Thor Motor Coach’s parts department.
