# XOS Technical Service Bulletin

Bulletin No.: REC-003-23

Subject: Electronic Parking Brake May Fail

Applicability: Xos 2021-2022 SV05, Xos 2021 SA01, Xos 2021-2022 RM01

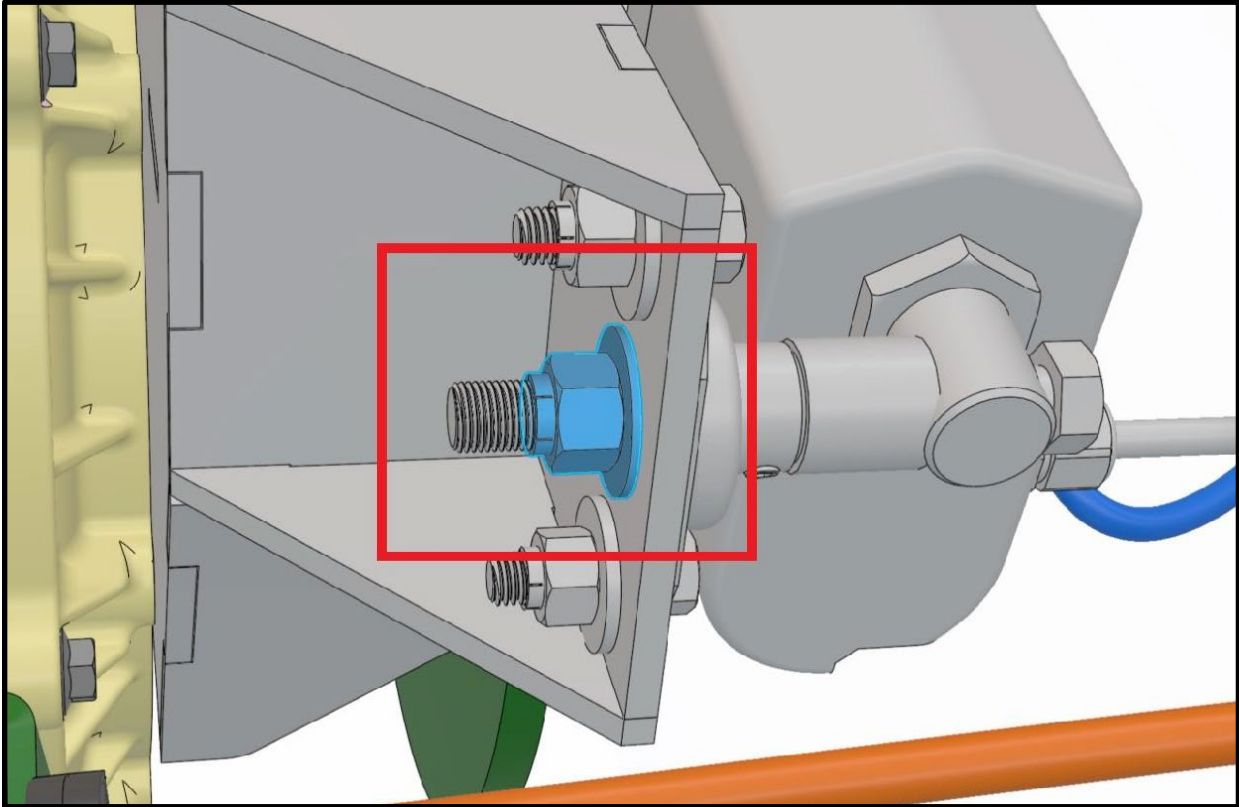
**Image 5: Remove the nut from the pivot bolt and discard the washer**

5. Go back under the vehicle to the EPB. Start by removing the nut from the pivot bolt on the actuator. The washer will be removed and not used anymore.

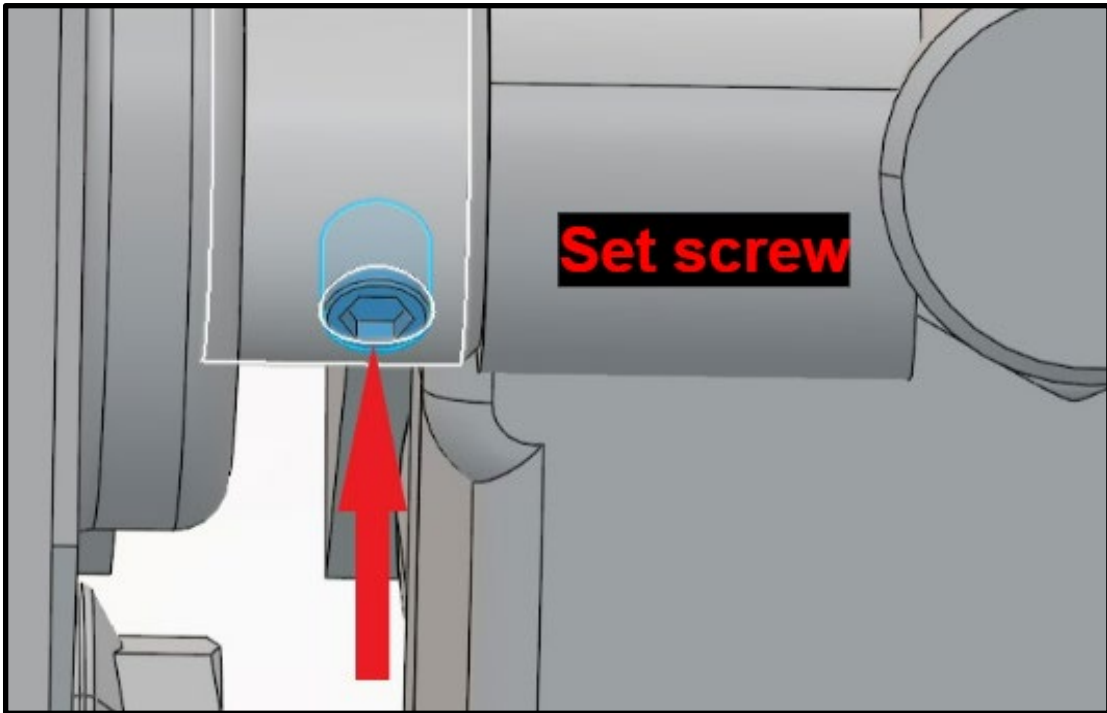
**Image 7: Adjust the set screw; verify that it is tightened to 13Nm.**

7. **Unbolt the set screw. Clean the screw with a wire brush and apply red Loctite before bolting it back. Tighten the set screw to 13Nm.**

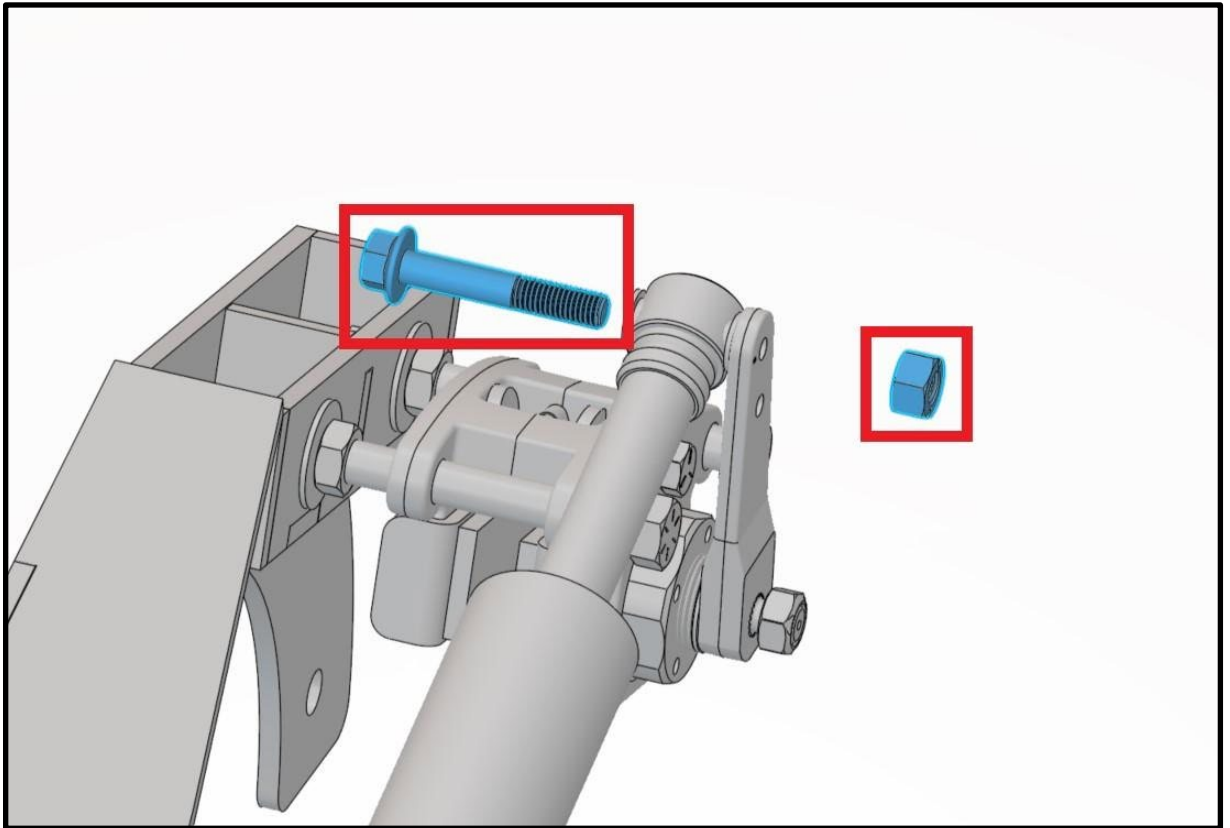
**Image 8: Remove Bolt HD20-HH-M0017 and Nut HD30-HH-M0048**

**8. Current hardware will be removed and replaced with new rework hardware.**

- **Remove Bolt: HD20-HH-M0017**
- **Remove Nut: HD30-HH-M0048**

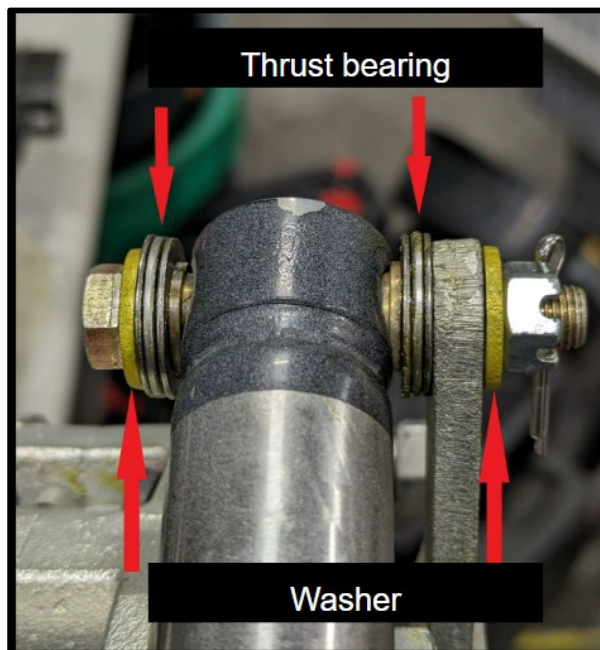
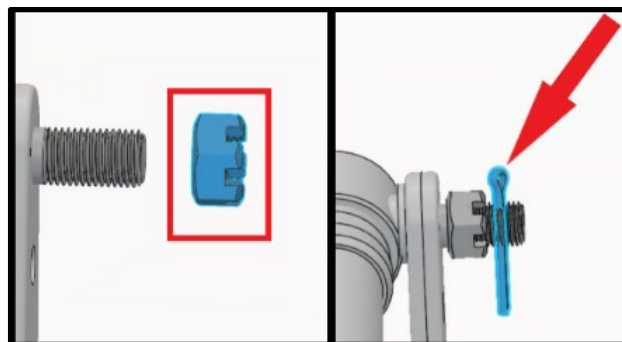
**Image 9: Install new hardware**

**9. New hardware to install:**

- **Cotter Pin-Lockable bolt 2-37/64 (94622A437)**
- **Thrust Needle Roller Bearings with Washers (AXK1024) (Apply bearing grease before installing)**
- **Steel Locknut, will need to add 2 x ( $\frac{3}{8}$ ) washers (90850A200) before locknut for spacing**
- **Carbon Steel Cotter Pin**

**Before torquing, verify calibration of EPB.**

- **Current acceptable measurements for EPB using PiSnoop software:  
Park: 0-2.5 Neutral: 3.7-4.3**
- **Torque lock nut to 5Nm**

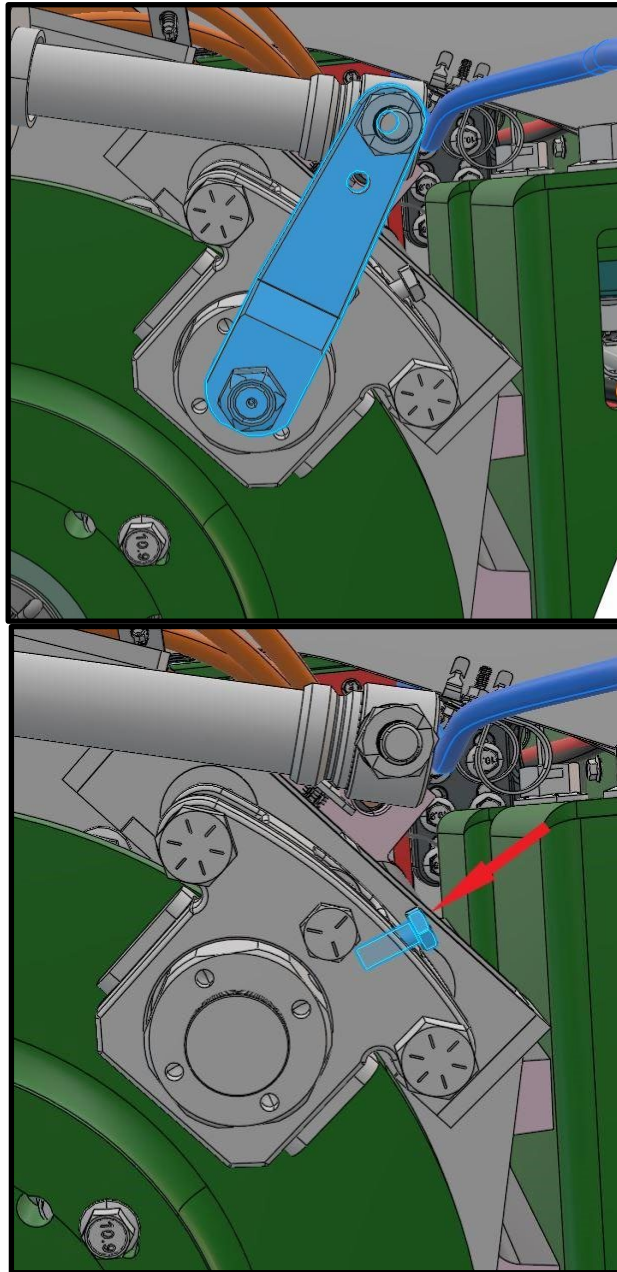
**Image 10: Adjustment steps (if necessary)**

**10. After adding the updated hardware, the caliper might need to be adjusted. If so, the following steps will show what needs to be done.**

- **Adjustment can be made by removing the caliper traveling arm.**
- **Set bolt will need to be loosened up also in order to rotate the actuator for the pad.**

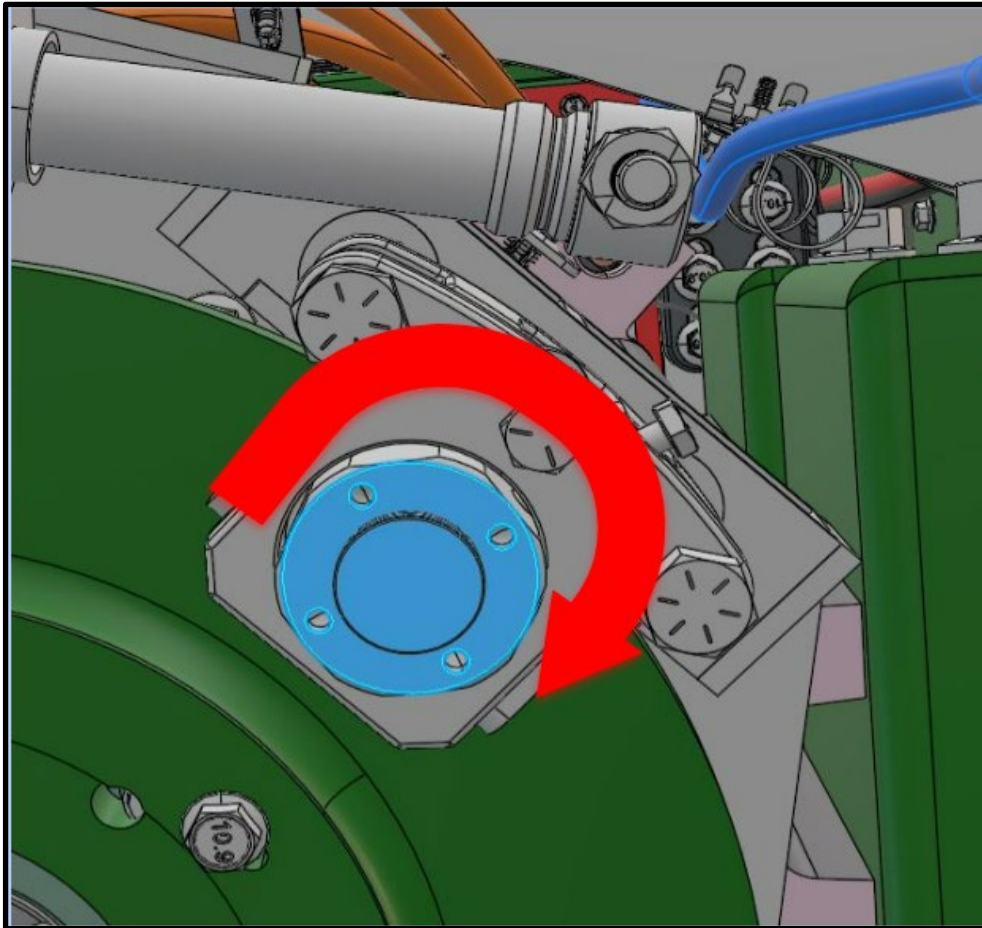
Image 11: Adjustment steps continued (if necessary)

11. (Continued) After adding the updated hardware, the caliper might need to be adjusted. If so, the following steps will show what needs to be done.

- Rotate clockwise  $\frac{1}{8}$  -  $\frac{1}{4}$  turn.
- Assemble the EPB caliper arm to caliper.
- Once all assembled, test the EPB and verify the measurements on Pismoop.

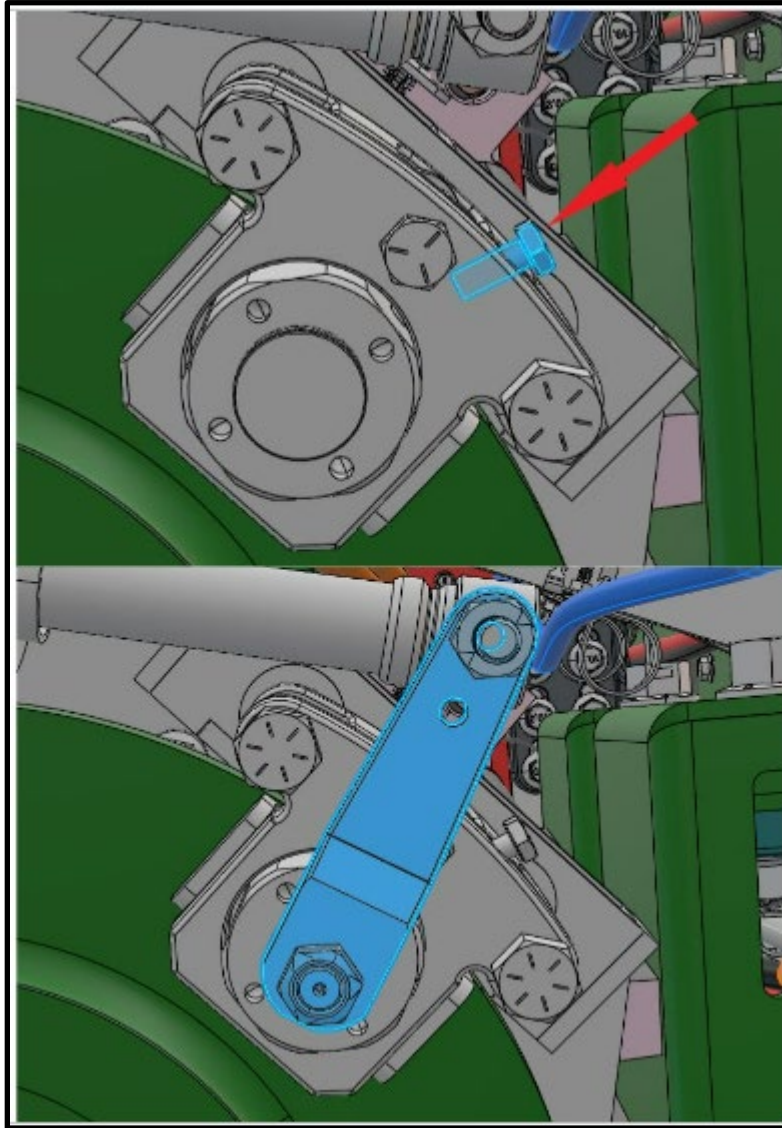
**Image 12: Adjustment steps continued (if necessary)**

**12. (Continued) After adjusting the caliper piston  $\frac{1}{8}$  -  $\frac{1}{4}$  turn clockwise, reassemble the parts as described below.**

- **Install the set screw and torque to 13 Nm.**
- **Install the traveling arm back on to the caliper and torque the Nut to 30 Nm.**
