SAFETY RECALL

Volvo Trucks North America

Date	Number	Release	Page
02. 2024	RVXX2312	01	1(8)

Volvo Passenger Side Bench Seat VHD, VN

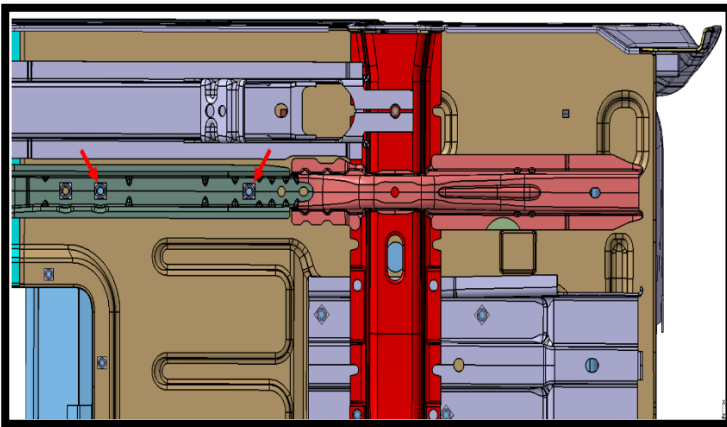
8. Locate the two weld nuts in the channel.

9. Remove the two weld nuts using an air hammer and chisel or equivalent.
