SIB 32 04 23

**RECALL 23V-770: REPLACE STEERING GEAR**

This Service Information Bulletin (Revision 1) replaces SI B32 04 23 **dated November 2023**.

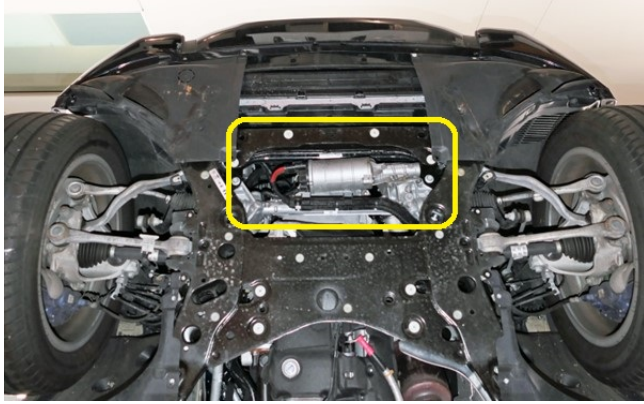
An internal component of the steering gear may not have been properly tightened during gear assembly by the supplier.

This can lead to excessive noise from within the steering gear, especially during tight corners such as when parking/maneuvering.

1. Raise vehicle on lift to access the steering gear (circled) beneath the vehicle.

G01 shown, G20 and G42 has a similar fitment.

2. Replace the steering gear as per AIR 32 13 572 Replace electrical steering box (EPS).

3. Perform initialization of the electromechanical steering per ISTA:
