SIB 32 04 23

2024-03-05

RECALL 23V-770: REPLACE STEERING GEAR

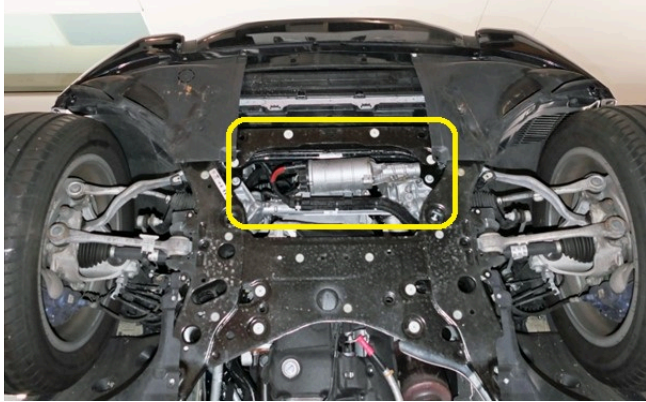
An internal component of the steering gear may not have been properly tightened during gear assembly by the supplier.

This can lead to excessive noise from within the steering gear, especially during tight corners such as when parking/maneuvering.

1. Raise vehicle on lift to access the steering gear (circled) beneath the vehicle.

G01 shown, G20 and G42 has a similar fitment.

Replace the steering gear as per AIR REP 32 13 572 Replace electrical steering box (EPS). Afterwards, initialize the steering using the latest ISTA (e.g., 4.44.3x, @ early Nov. 2023).

2. Replace the steering gear as per AIR 32 13 572 Replace electrical steering box (EPS).
