SIB 32 04 23

RECALL 23V-770: REPLACE STEERING GEAR

This Service Information Bulletin (Revision 1) replaces SI B32 04 23 **dated November 2023**.

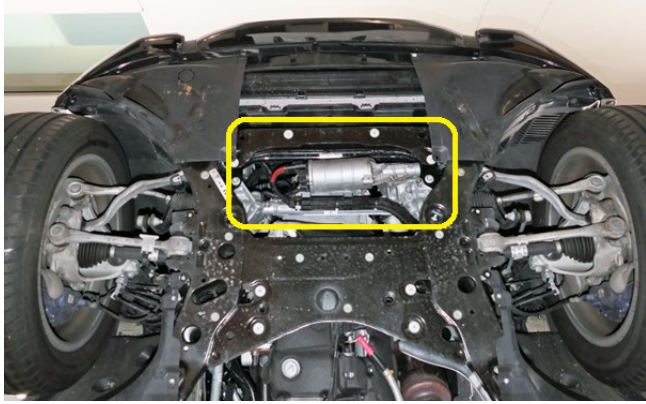
An internal component of the steering gear may not have been properly tightened during gear assembly by the supplier.

This can lead to excessive noise from within the steering gear, especially during tight corners such as when parking/maneuvering.

1. Raise vehicle on lift to access the steering gear (circled) beneath the vehicle.

G01 shown, G20 and G42 has a similar fitment.

2. Replace the steering gear as per AIR 32 13 572 Replace electrical steering box (EPS).

3. Perform initialization of the electromechanical steering per ISTA:
