R23CU: Right Front Barrier Securement

Models Affected: Certain 2015-2025 Model Year All American Rear Engine School and Non-School Buses

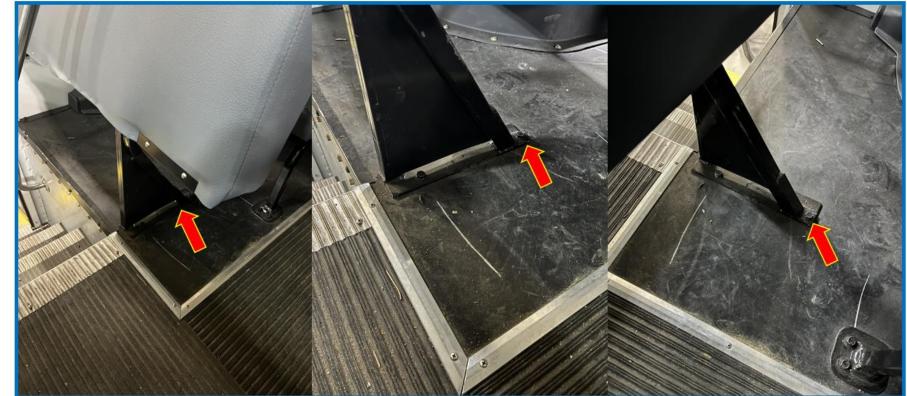
1. Remove fastener highlighted in Fig 1.
