PREVOST

SAFETY RECALL

SR23-43

DATE :	January 2024	SECTION :	23 ACCESSORIES
SUBJECT:	PREVOST DRIVER ASSIST – VERIFICATION OF ACB RADAR SENSOR FRONT BUMPER TRIM

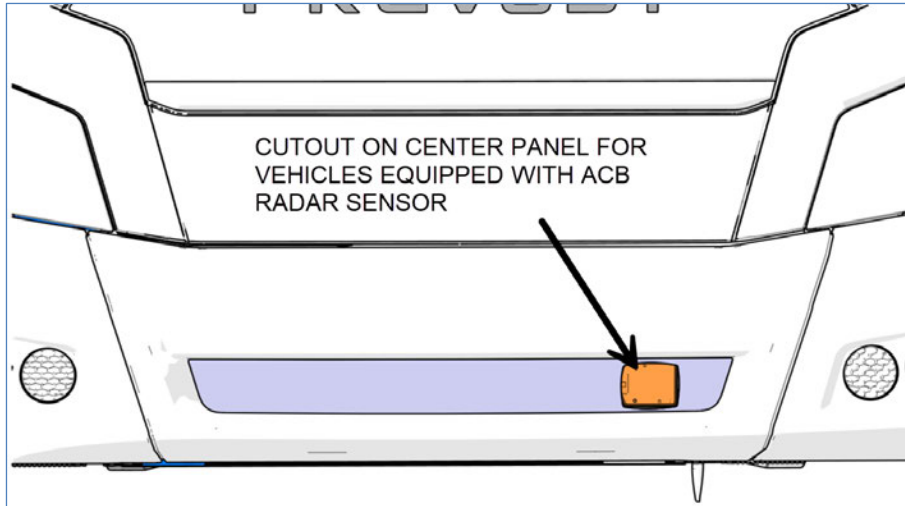
1. Vehicles equipped with the ACB radar sensor should have a cutout on the front bumper trim as seen on the image below.

Figure 1: VEHICLE EQUIPPED WITH ACB RADAR SENSOR

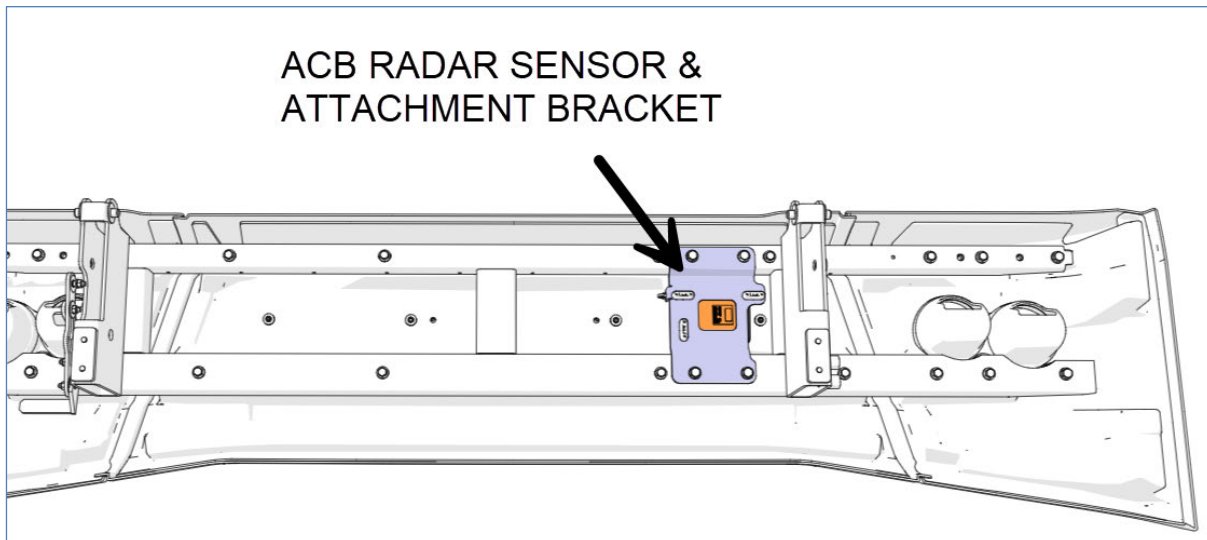
2. Open the reclining bumper. Confirm your vehicle is equipped with the ACB radar sensor.

Figure 2: VEHICLE EQUIPPED WITH ACB RADAR SENSOR

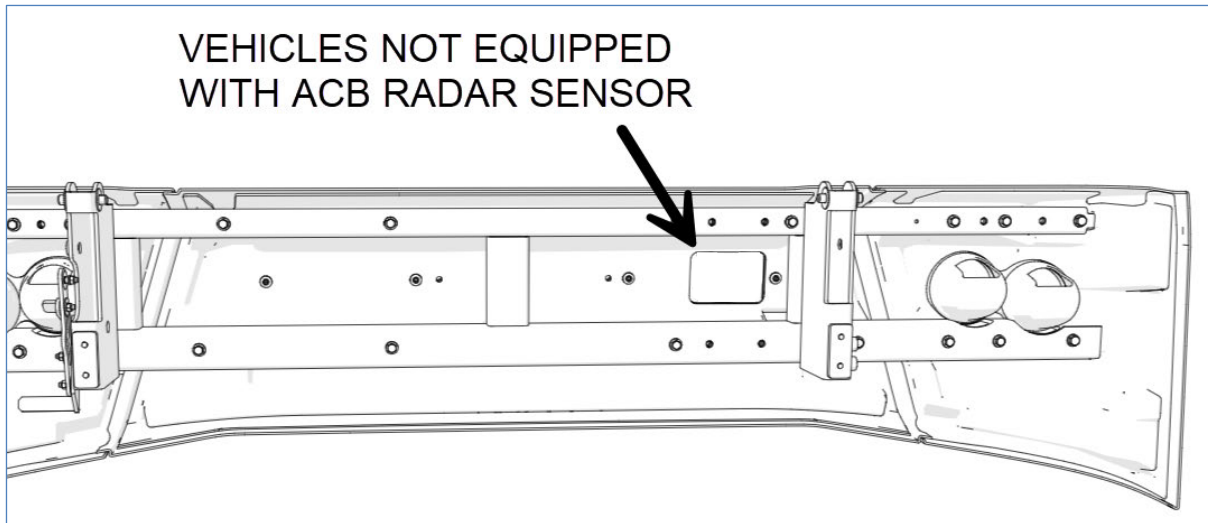
Figure 3 : VEHICLE NOT EQUIPPED WITH ACB RADAR SENSOR

3. If the front bumper trim installed on your vehicle **is** the appropriate one, no further steps are required. This completes the bulletin.
4. If the front bumper trim installed on your vehicle **is not** the appropriate one, perform PART 2 - FRONT BUMPER TRIM REPLACEMENT.
