Released Date	03/01/2024	
Doc No.	IARCM002876	
Title	Rear Winch Relay Wiring – Inspect – US Only	
Affected Vehicle(s) / VINs	Grenadier	RF006407 - RF007554
Prior to starting any reworks, please make sure you check the vehicle is affected by checking the VIN using Vehicle Simple Search in the Warranty System.

Rear Winch Relay Wiring – Inspect

Rear Winch Relay Wiring - Repair

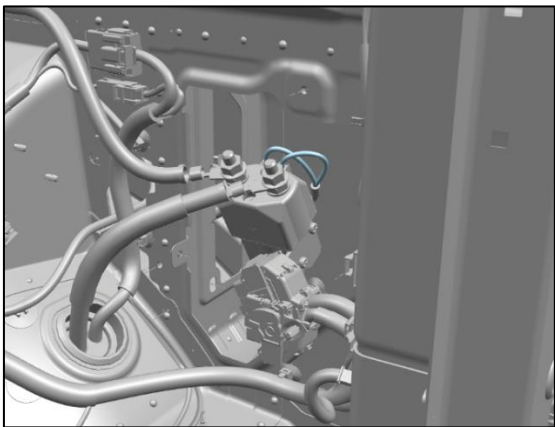
1	Remove the Right Loading Space Trim Panel. Refer to: TOPIC_0000001524 Loading Space Trim Panel Right (Remove for Access and Install)
2	<p>Note: Both relay wires shown in blue are at risk of being trapped by either terminal nut on the relay. Make sure both are inspected.</p> <p>Visually inspect the wiring around the Rear Winch Relay.</p>

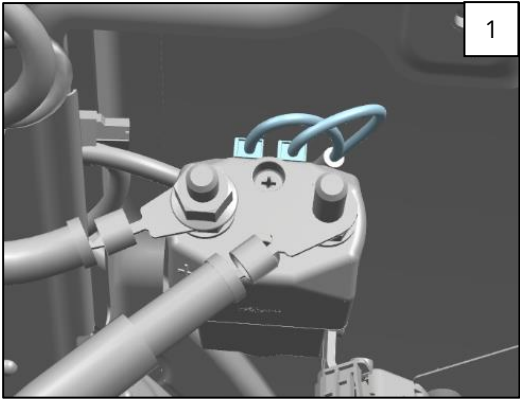
<p>1</p> </div> <div style="font-size: 48px; color: green;">✓</div> </div> <div style="display: flex; justify-content: space-around; align-items: center; margin-top: 10px;"> <div style="text-align: center;">

<ul style="list-style-type: none"> - If the relay wires are positioned correctly and not trapped under the terminal nuts (as shown in image 1), proceed to step 3. - If the relay wire(s) are trapped under either of the terminal nuts (as shown in image 2), proceed to the Rear Winch Relay Wiring - Repair rework instructions. <div style="display: flex; justify-content: space-around; align-items: center;"> <div style="text-align: center;">

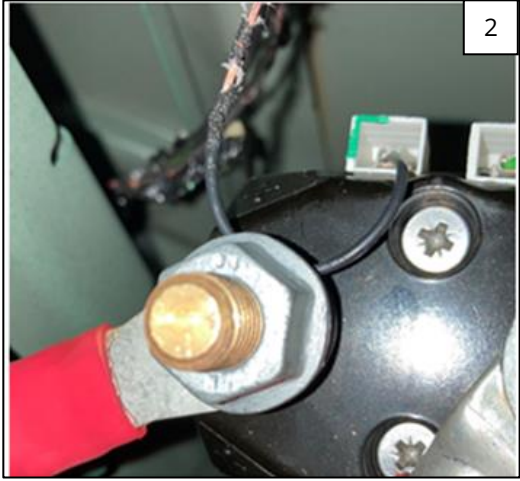
<p>2</p> </div> <div style="font-size: 48px; color: red;">✗</div> </div>
3	Install the Loading Space Trim Panel Right. Refer to: TOPIC_000001524 Loading Space Trim Panel Right (Remove for Access and Install)
4	Release the vehicle.

Issue: An issue has been identified on a small number of the affected vehicles where the Rear Winch Relay Wiring may be damaged/trapped.

Cause: Manufacturing Issue.

5	Cut out the damaged section of wire with an appropriate tool.
6	Use a Heat Shrink Splice Connector to reconnect the wire and crimp with an appropriate tool.
7	Apply heat to the Heat Shrink Splice Connector until it has sealed around the wire.
8	Repeat steps 5 - 7 on the other relay wire if it was also trapped as inspected in step 2 of the 'Inspect' procedure.
