GROUP	MODEL
Safety Recall Campaign	2023MY Soul (SK3) and 2024MY Seltos (SP2)
NUMBER	DATE
SC289	February 2024

CURTAIN AIRBAG MODULE INSPECTION AND REPLACEMENT (SC289)

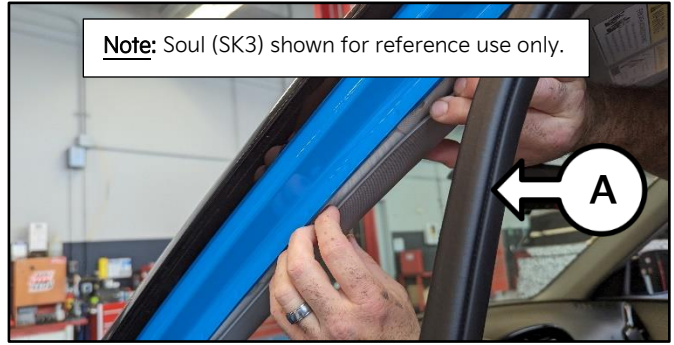
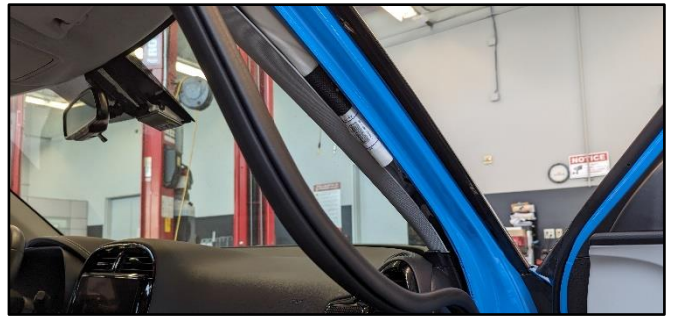
1. Disconnect the 12V battery negative (-) cable.
2. Detach the top of the left driver side front door side weatherstrip (A), along the A-Pillar and roof area.
3. Partially detach the A-front pillars on both left and right side as shown.
4. Repeat steps 1-2 for the right passenger side.

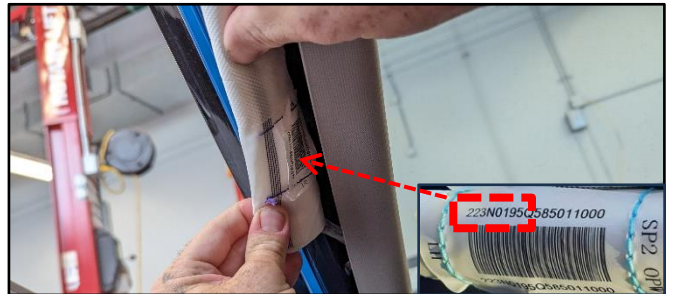
5. Locate the curtain airbag barcode label and note (write down) the first 8 digits of the LOT number of both CAB modules.

Note: The left side may require to be pulled and twisted to view the label.

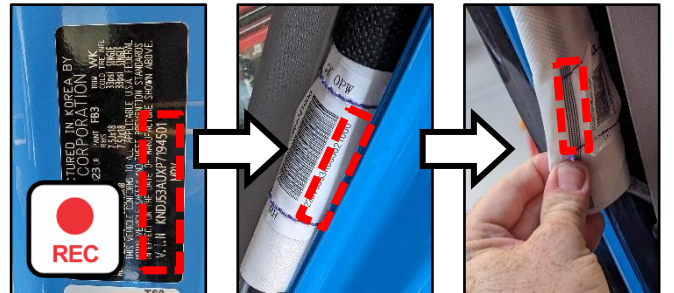
6. Using KVID, take a continuous clear video starting from the VIN label and clearly displaying the two (2), left and right side CAB module LOT numbers and submit it with claim.

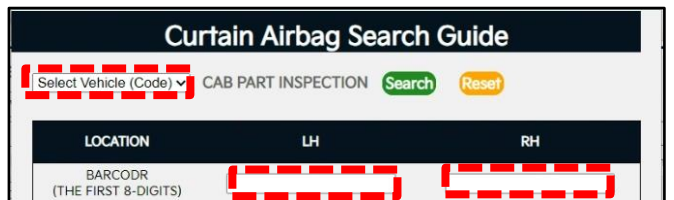
8. Enter the applicable LOT numbers (Left and Right side) in the table shown to verify if one, both or none of the curtain airbags modules require replacement.

9.
 - If the result is **OK**, reinstall all removed parts in the reverse order of removal. No further action is required.
 - If the result is **NG** for the left and/or right curtain airbags, then proceed to the replacement procedure outlined on page 3.

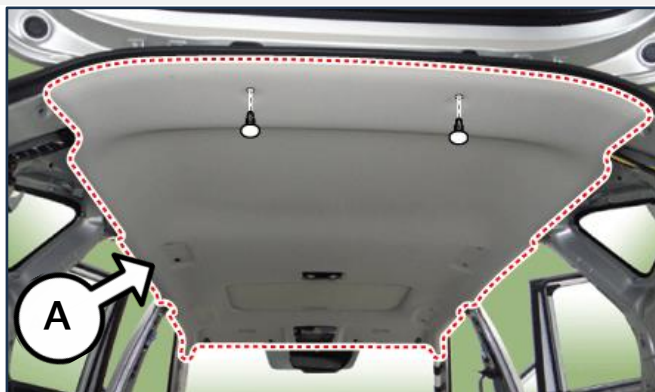
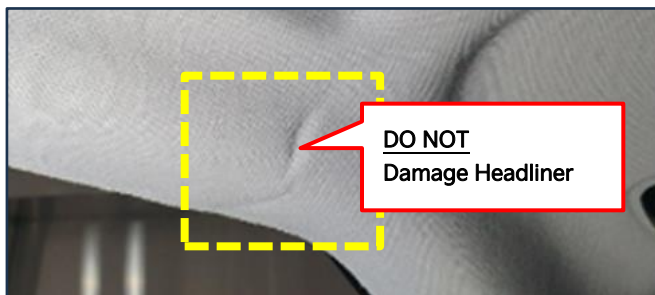
1. Carefully, remove the roof trim assembly (A) by referring to "Body (Interior and Exterior) → Roof Trim → Repair procedures" in the applicable Shop Manual on KGIS.

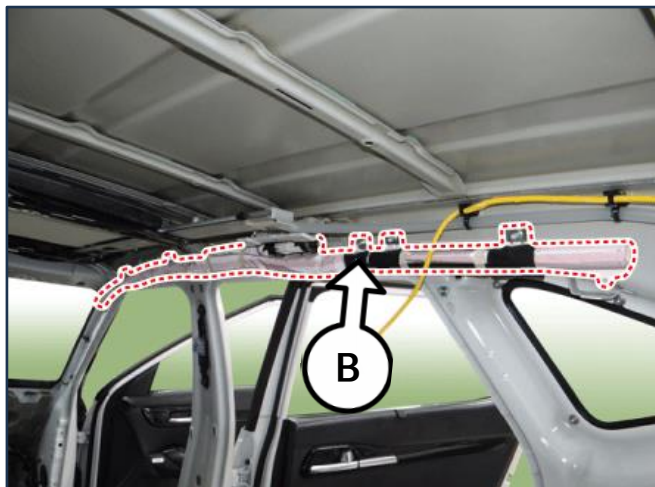
2. Replace the applicable **NG** (left and/or right side) curtain airbag module (B) with a new part by referring to "Restraint → Airbag Module → Curtain Airbag (CAB) Module → Repair procedures" in the applicable Shop Manual on KGIS.

Be sure to replace any existing clips/fasteners with new parts provided in the CAB kit.
