Recall Campaign Bulletin

Campaign No. 2023120010, December 2023

SUBJECT: **Model GLE (167 platform)**
Model Year 2021-2022

Check the 12V Ground Connection Bolt Torque

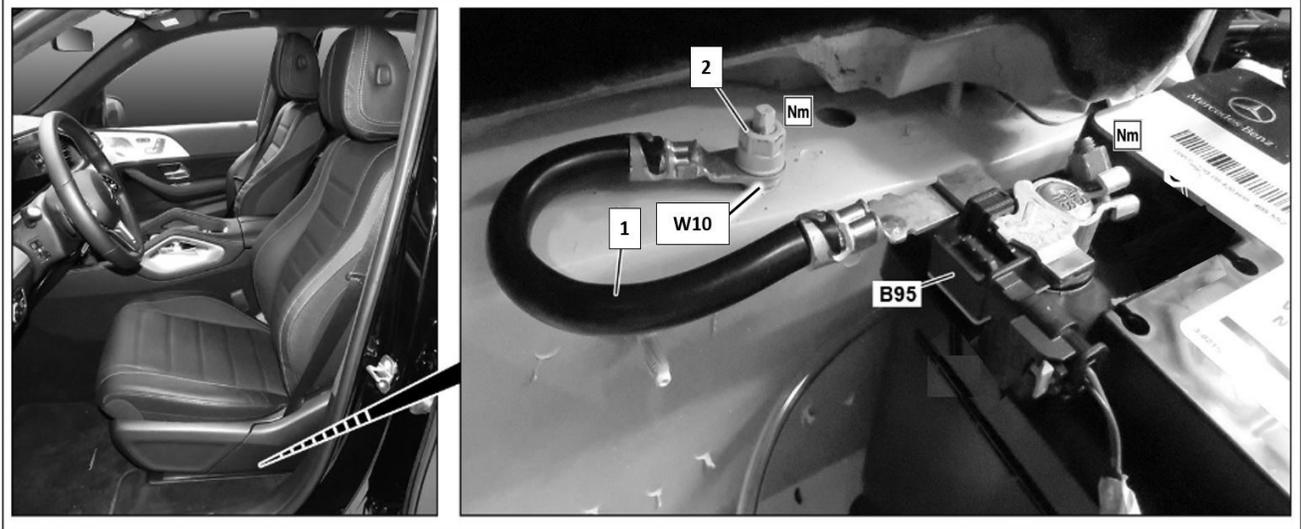
Figure 1

1. Visually check ground point (W10, Figure 1) and ground line (1, Figure 1) under the driver's seat for damage.
 - i** For basic information, see AR54.10-P-0002ME.

- a. If **no damage** is present:
Carry out Check/test Procedure 2.
- b. If **there is damage** to the ground line (1, Figure 1) or ground point (W10, Figure 1):
Carry out Work Procedure 2.

2. Check nut (2, Figure 1) for correct tightening torque.
 - i** For basic information, see AR54.10-P-0002ME.
 - a. If tightening torque of nut (2, Figure 1) is correct and no damage present:
End measure.
 - b. If tightening torque of nut (2, Figure 1) **is not correct**:
Carry out Check/test Procedure 3.

5. Install existing ground line (1, Figure 1) including battery sensor (B95, Figure 1) with **new** nut (2, Figure 1) and **tighten** with prescribed tightening torque.
i For basic information, see AR54.10-P-0002ME.

6. **Clean** area around ground point (W10, Figure 1) and threaded pin.
i If necessary, recut threaded pin using a thread cutter.
7. **Replace** ground line (1, Figure 1) including battery sensor (B95, Figure 1) and nut (2, Figure 1).
i For basic information, see AR54.10-P-0002ME.
8. Perform commissioning of battery sensor (B95).
i For basic information, see AD00.00-P-2000-06ME.

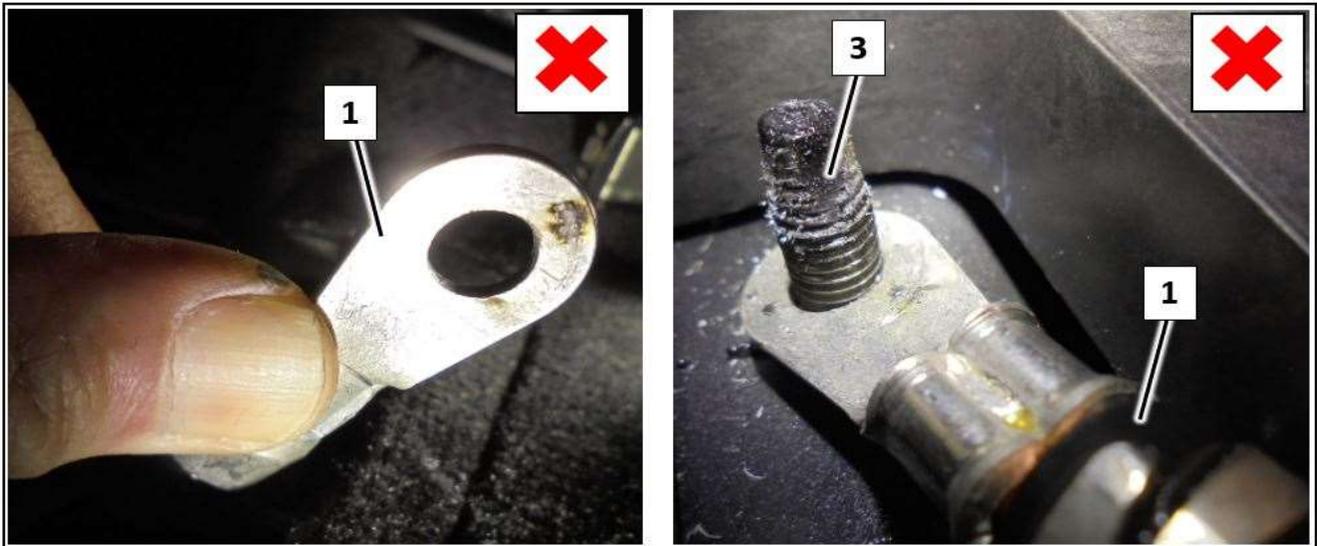
**Figure 2**

3. Remove nut (2, Figure 1) and ground point (W10, Figure 1) from body.
i For basic information, see AR54.10-P-0002ME.
4. Check threaded pin (3, Figure 2) and cable lug or ground line (1, Figure 2) for damage.

- a. If there is **no damage** at threaded pin (3, Figure 2) and cable lug or ground line (1, Figure 2):
Carry out Work Procedure 1.
- b. If **damage** is present at threaded pin (3, Figure 2) and cable lug or ground line (1, Figure 2):
Carry out Work Procedure 2.
