#N232421970-01: Safety Recall - Seatbelt Pretensioner Recall 22V930 (N222383790) Not Completed - (Jan 11, 2024)

Subject: N232421970 – Seatbelt Pretensioner Recall 22V930 (N222383790) Not Completed

Models: 2020–2023 Chevrolet Bolt EV

Release Date: January 2024	Revision: 01
Revision Description:	This bulletin has been revised to add the customer notification letter. Please discard all previous copies of N232421970.

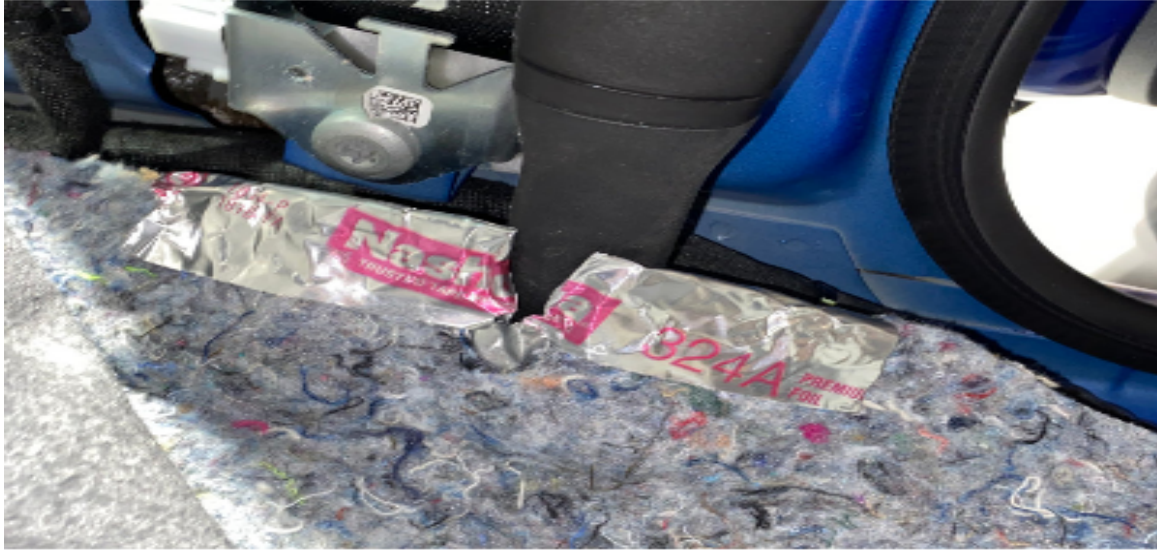
19. Inspect the carpet to see if foil tape is installed as described in this procedure, see above.
 - If the foil tape is installed, proceed to step 26.
 - If the foil tape is NOT installed, complete the following and proceed to step 20.
