#N232421971-01: Safety Recall - Seatbelt Pretensioner Recall 22V930 (N222383791) Not Completed - (Jan 11, 2024)

Subject: N232421971 – Seatbelt Pretensioner Recall 22V930 (N222383791) Not Completed

Models: 2017–2020 Chevrolet Bolt EV

| Release Date: January 2024 | Revision: 01 |

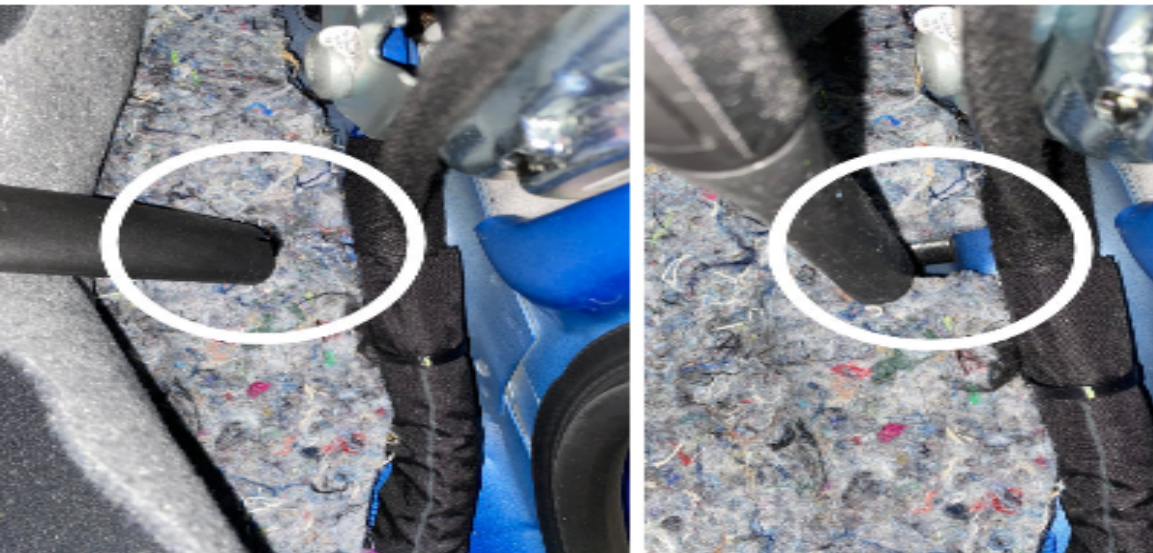
18. Pull the carpet back around the seat belt pretensioner to expose the insulation on the passenger's side of the vehicle.

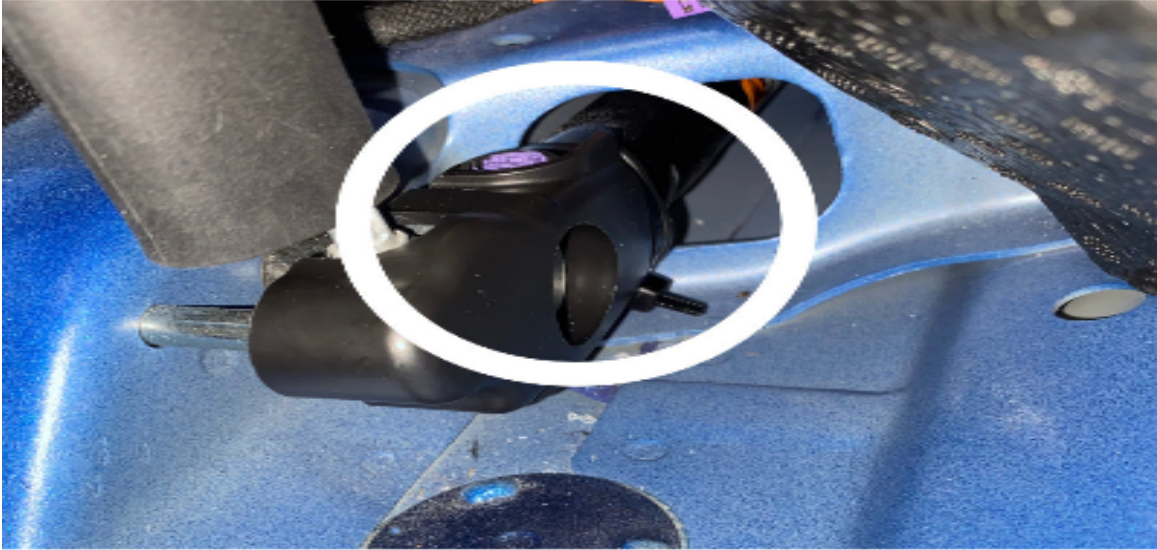
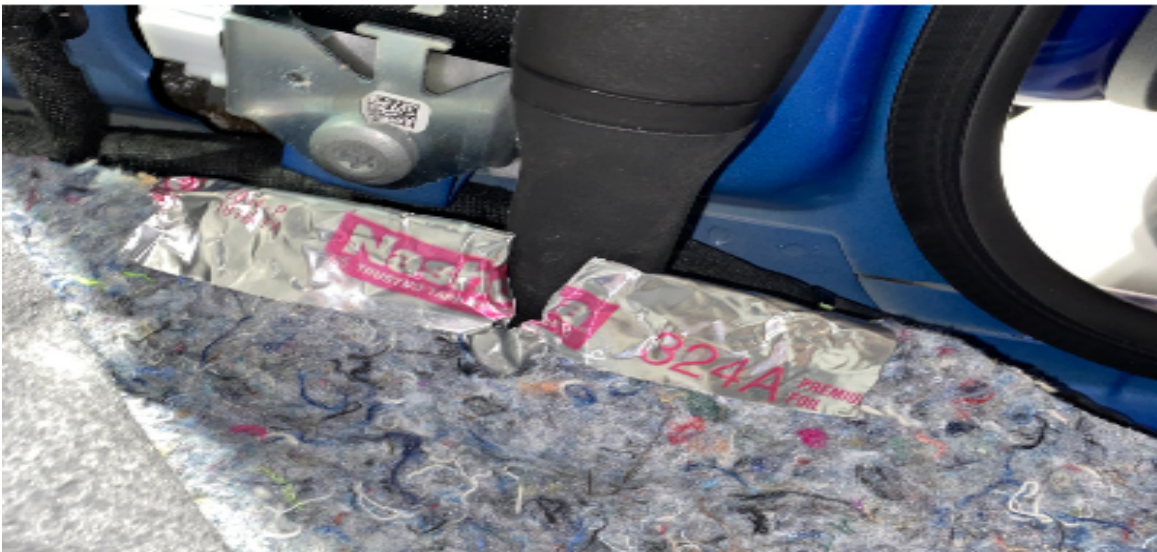
19. Inspect the carpet to see if foil tape AND the cover is installed as described in this procedure, see above.
 - If the foil tape AND cover are installed, proceed to step 26.

– If the foil tape AND/OR cover is NOT installed, complete the following and proceed to step 20.
