# Safety Recall

## N232425643 Both Roof Rail Airbag Inflators May Rupture

**Release Date:** October 2024

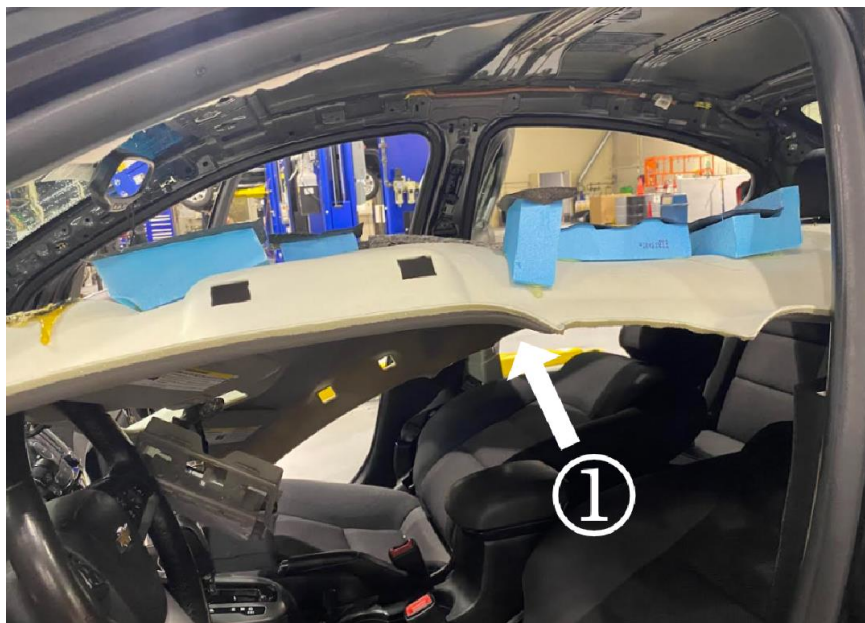
6449517

**Note:** The Headlining Trim Panel only needs to be lowered NOT removed. DO NOT remove the seats as the SI document states. Seat removal is ONLY for headliner removal NOT headliner lowering.

3. Lower the Headlining Trim Panel onto the headrests of the seats (1) as shown above. Refer to *Headlining Trim Panel Replacement* in SI.
4. Remove and replace BOTH the Left Hand and Right Hand Roof Side Rail Airbags. Refer to *Roof Side Rail Airbag Replacement* in SI.
5. Reinstall the Headlining Trim Panel. Refer to *Headlining Trim Panel Replacement* in SI.
6. Enable the SIR system. Refer to *SIR Disabling and Enabling* in SI.
7. Return the Front Seats to their original location.
