Safety Recall

N232425643 Both Roof Rail Airbag Inflators May Rupture

Release Date: April 2025

Revision: 02

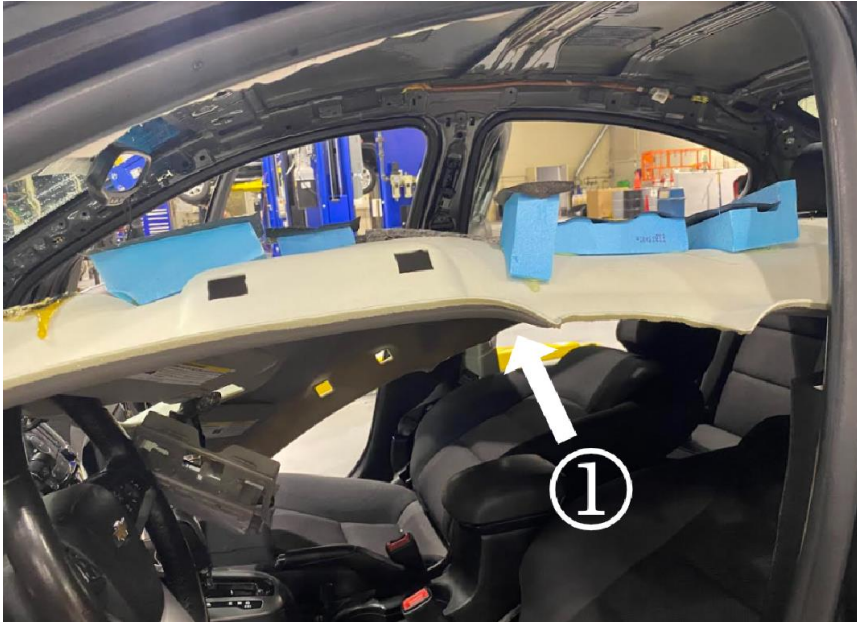
Note: The Headlining Trim Panel only needs to be lowered NOT removed. DO NOT remove the seats as the SI document states. Seat removal is ONLY for headliner removal NOT headliner lowering.

3. Lower the Headlining Trim Panel onto the headrests of the seats (1) as shown above. Refer to *Headlining Trim Panel Replacement* in SI.
4. Remove and replace BOTH the Left Hand and Right Hand Roof Side Rail Airbags. Refer to *Roof Side Rail Airbag Replacement* in SI.
5. Reinstall the Headlining Trim Panel. Refer to Refer to *Headlining Trim Panel Replacement* in SI.
6. Enable the SIR system. Refer to *SIR Disabling and Enabling* in SI.
7. Return the Front Seats to their original location.
8. Return the used RRAB following the return instructions at the top of this bulletin.
