# Safety Recall

## N232425642 Right Roof Rail Airbag Inflator May Rupture

Release Date: June 2024

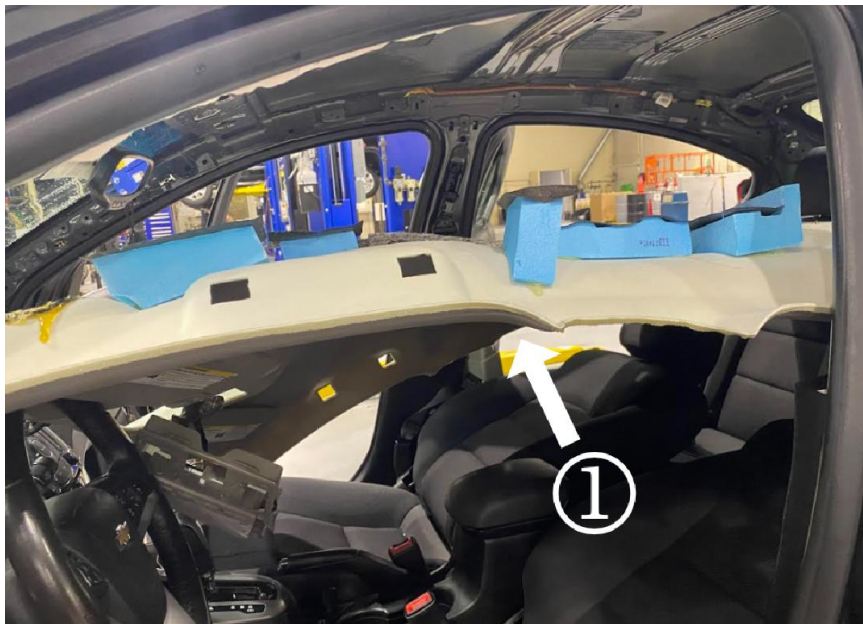
6449517

**Note:** The Headlining Trim Panel only needs to be lowered NOT removed. DO NOT remove the seats as the SI document states. Seat removal is ONLY for headliner removal NOT headliner lowering.

**Note:** Left side shown, right side similar.

3. Lower the Headlining Trim Panel onto the headrests of the seats (1) as shown above. Refer to *Headlining Trim Panel Replacement* in SI.
4. Remove and replace the Right Hand Roof Side Rail Airbag. Refer to *Roof Side Rail Airbag Replacement* in SI.
5. Reinstall the Headlining Trim Panel. Refer to *Headlining Trim Panel Replacement* in SI.
