# Safety Recall

## N232425641 Left Roof Rail Airbag Inflator May Rupture

**Release Date:** September 2024

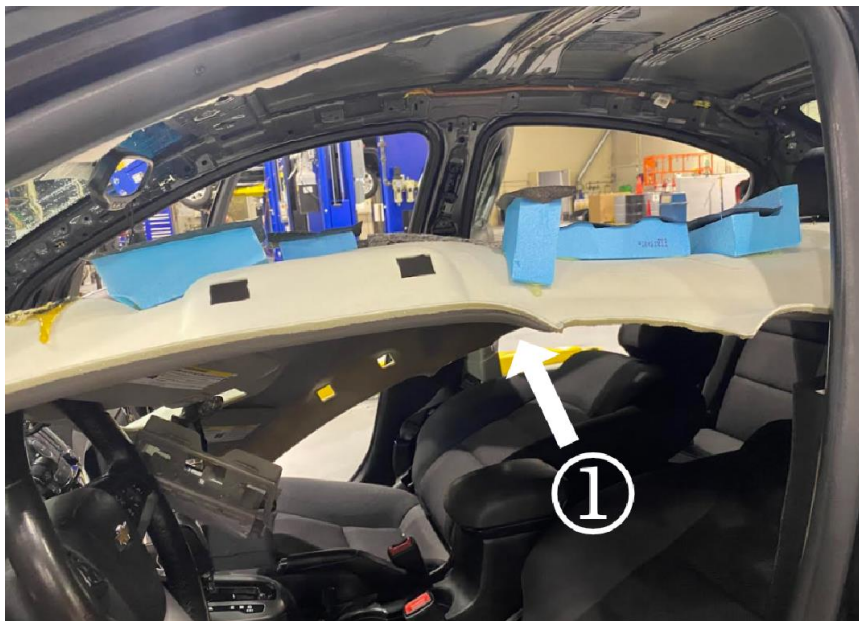
**Note:** The Headlining Trim Panel only needs to be lowered NOT removed. DO NOT remove the seats as the SI document states. Seat removal is ONLY for headliner removal NOT headliner lowering.

3. Lower the Headlining Trim Panel onto the headrests of the seats (1) as shown above. Refer to *Headlining Trim Panel Replacement* in SI.
4. Remove and replace the Left Hand Roof Side Rail Airbag. Refer to *Roof Side Rail Airbag Replacement* in SI.
5. Reinstall the Headlining Trim Panel. Refer to *Headlining Trim Panel Replacement* in SI.
