# Safety Recall

## N232425640 Both Roof Rail Airbag Inflators May Rupture

**Release Date:** September 2024

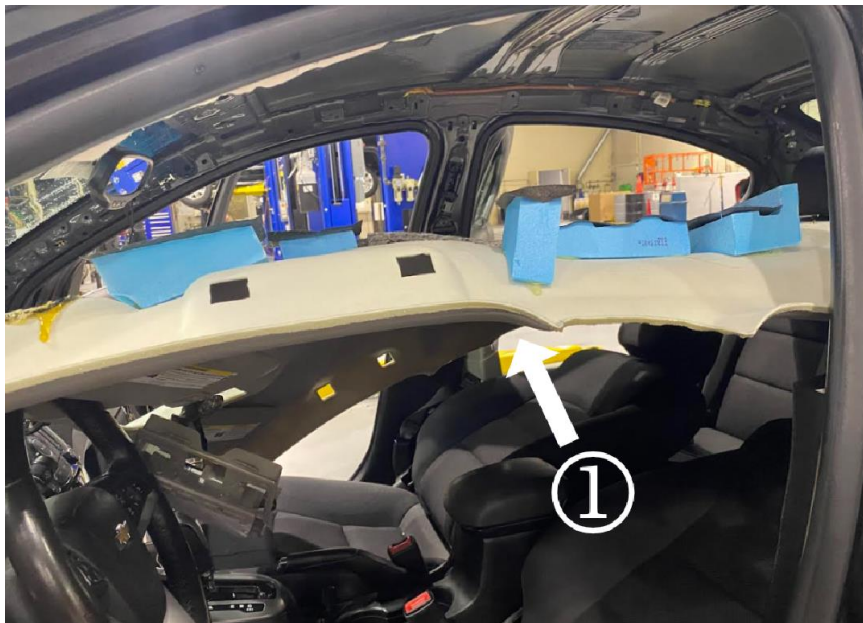
**Note:** The Headlining Trim Panel only needs to be lowered NOT removed. DO NOT remove the seats as the SI document states. Seat removal is ONLY for headliner removal NOT headliner lowering.

3. Lower the Headlining Trim Panel onto the headrests of the seats (1) as shown above. Refer to *Headlining Trim Panel Replacement* in SI.
4. Remove and replace BOTH the Left Hand and Right Hand Roof Side Rail Airbags. Refer to *Roof Side Rail Airbag Replacement* in SI.
5. Reinstall the Headlining Trim Panel. Refer to *Headlining Trim Panel Replacement* in SI.
6. Enable the SIR system. Refer to *SIR Disabling and Enabling*.
