# Safety Recall

## N232425642 Right Roof Rail Airbag Inflator May Rupture

**Release Date:** September 2024

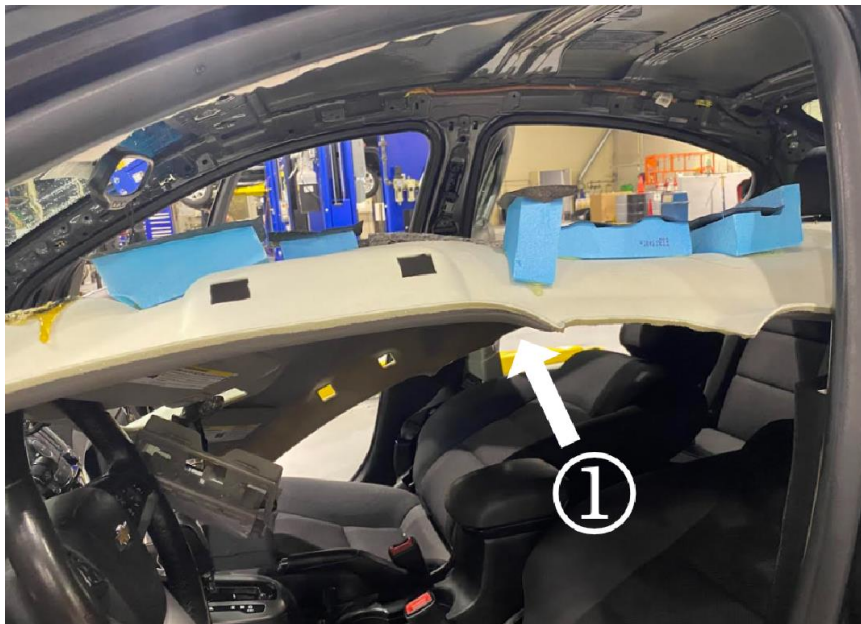
6449517

**Note:** The Headlining Trim Panel only needs to be lowered NOT removed. DO NOT remove the seats as the SI document states. Seat removal is ONLY for headliner removal NOT headliner lowering.

**Note:** Left side shown, right side similar.

3. Lower the Headlining Trim Panel onto the headrests of the seats (1) as shown above. Refer to *Headlining Trim Panel Replacement* in SI.
4. Remove and replace the Right Hand Roof Side Rail Airbag. Refer to *Roof Side Rail Airbag Replacement* in SI.
5. Reinstall the Headlining Trim Panel. Refer to *Headlining Trim Panel Replacement* in SI.
