# Safety Recall

## N232425643 Both Roof Rail Airbag Inflators May Rupture

**Release Date:** September 2024

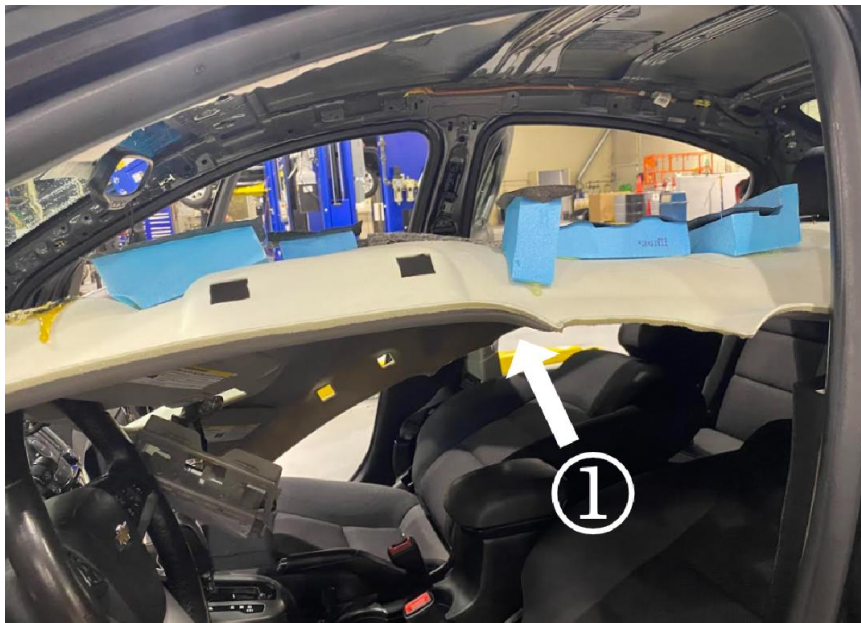
**Note:** The Headlining Trim Panel only needs to be lowered NOT removed. DO NOT remove the seats as the SI document states. Seat removal is ONLY for headliner removal NOT headliner lowering.

3. Lower the Headlining Trim Panel onto the headrests of the seats (1) as shown above. Refer to *Headlining Trim Panel Replacement* in SI.
4. Remove and replace BOTH the Left Hand and Right Hand Roof Side Rail Airbags. Refer to *Roof Side Rail Airbag Replacement* in SI.
5. Reinstall the Headlining Trim Panel. Refer to *Headlining Trim Panel Replacement* in SI.
6. Enable the SIR system. Refer to *SIR Disabling and Enabling* in SI.
7. Return the Front Seats to their original location.
