Safety Recall

N232425641 Left Roof Rail Airbag Inflator May Rupture

Release Date: June 2024

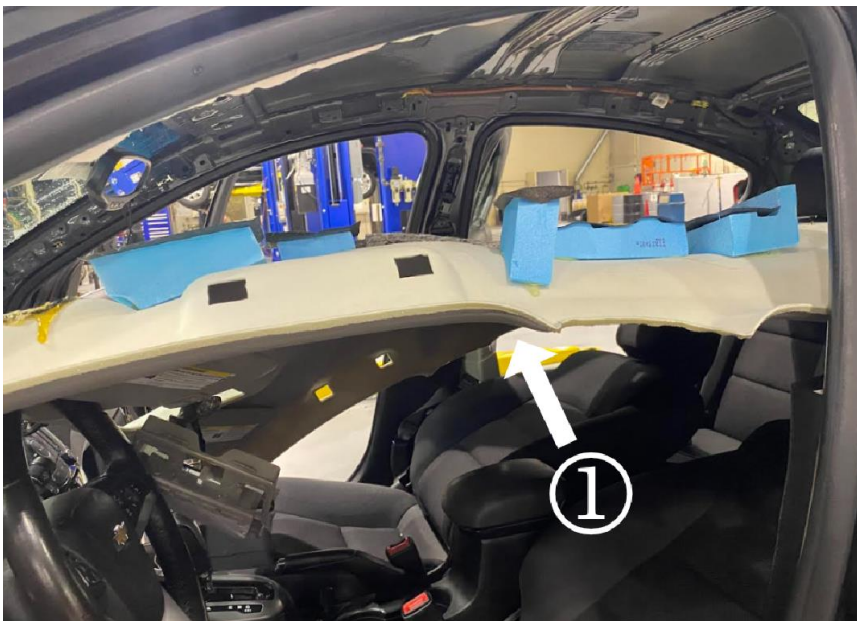
6449517

Note: The Headlining Trim Panel only needs to be lowered NOT removed. DO NOT remove the seats as the SI document states. Seat removal is ONLY for headliner removal NOT headliner lowering.

3. Lower the Headlining Trim Panel onto the headrests of the seats (1) as shown above. Refer to *Headlining Trim Panel Replacement* in SI.
4. Remove and replace the Left Hand Roof Side Rail Airbag. Refer to *Roof Side Rail Airbag Replacement* in SI.
5. Reinstall the Headlining Trim Panel. Refer to Refer to *Headlining Trim Panel Replacement* in SI.
