Model	Model Description	Model Code
K35	R 18 Bagger	0L33
K35	R 18 Transcontinental	01 43

The affected vehicles have been marked with campaign number 0000630500 in AIR.

SITUATION

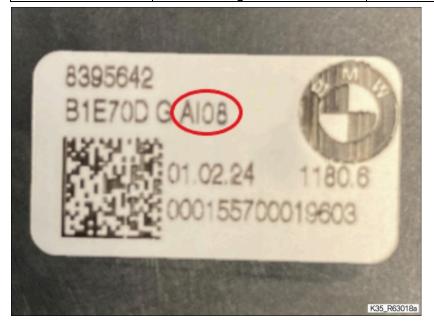
It is **CRUCIAL** to ensure and double check that only a new headlight **with the correct revision index (AI)** is used. This can be determined by the corresponding identification. Any other revision index that is not listed below is not a new headlight.

Part number	Part description	Revision Index	Version
63 12 8 395 642	LED Headlight Pro	Al07 or higher	New
63 12 8 395 649	LED Headlight Pro black	Al03	New

63 12 8 395 641 LED Headlight Basic Al07 New

In affected vehicles, the LED headlight must be replaced in accordance with the amended repair instructions "63 12 091 – Replacing headlights" (listed below and will be available in AIR from 08/24).
