PREVOST

**SAFETY
RECALL**

SR23-07

| SUBJECT: | Hazard Warning Lights Synchronization | | |

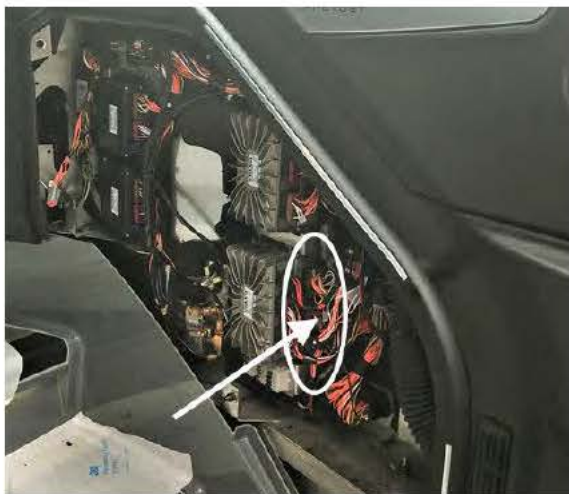
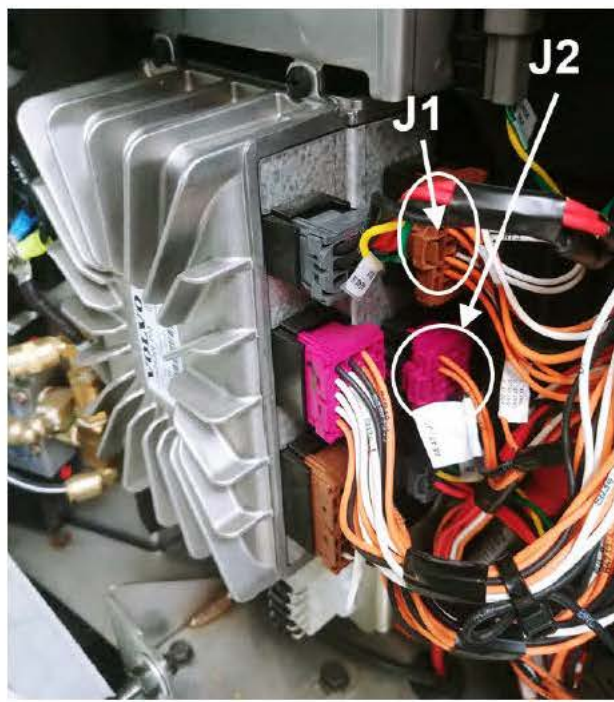
2. Locate the faulty connection.

- Locate the **A47 I/OB** module in the compartment as shown.
- On the side of the module, locate the **J1** and **J2** connectors.
