AUTOCAR, LLC SAFETY RECALL ACX-2305 DC-2301

May 2023

Autocar, LLC has determined the drive line center support bearing hardware may not be properly secured on certain Xpeditor (ACX) and Legend (DC) vehicles.

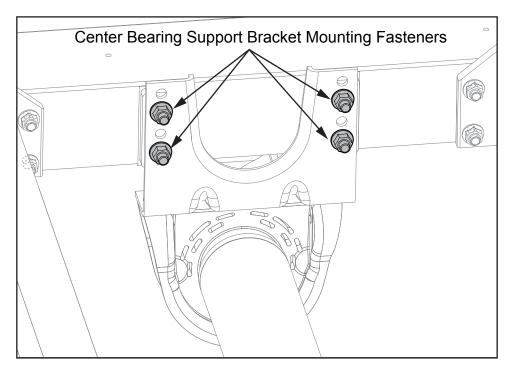
Figure 1, ACX vehicles with aluminum cross members

3. For ACX vehicles equipped with aluminum cross members. Locate the 4 center bearing support bracket mounting fasteners and tighten to 90 Lbs-ft of torque (see Figure 1).

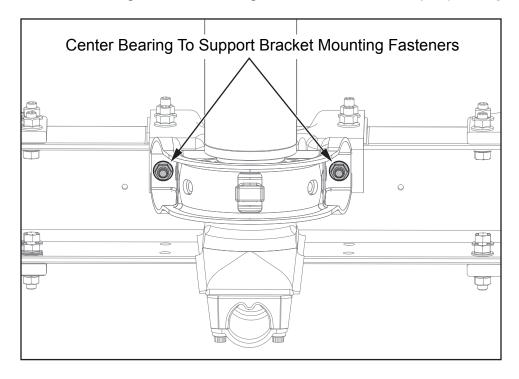
Figure 2, ACX vehicles with aluminum cross members

4. For ACX vehicles equipped with aluminum cross members. Locate the 2 center bearing to support bracket mounting fasteners and tighten to 59 Lbs-ft of torque (see Figure 2).

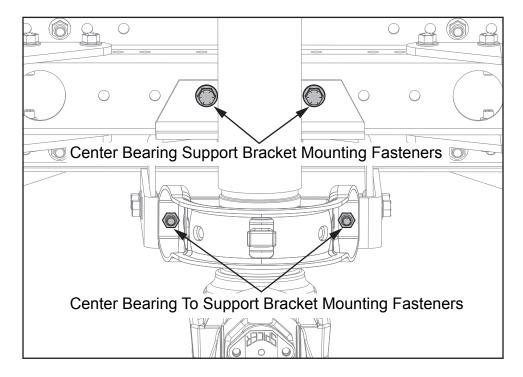
Figure 3, ACX vehicles with steel cross members

5. For ACX vehicles equipped with steel cross members. Locate the 2 center bearing support bracket mounting fasteners and tighten to 90 Lbs-ft of torque and locate the 2 center bearing to support bracket mounting fasteners and tighten to 59 Lbs-ft of torque (see Figure 3).

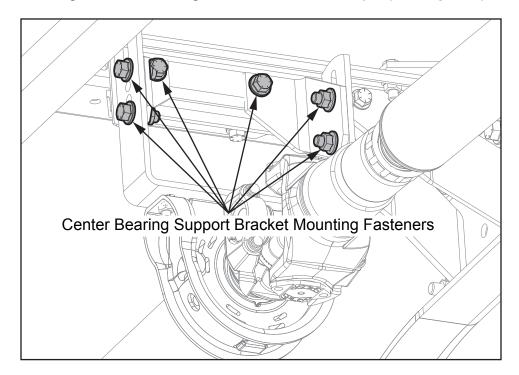
Figure 4, ACX vehicles with steel cross members

6. For ACX vehicles equipped with steel cross members. Locate the 6 center bearing support bracket mounting fasteners and tighten to 90 Lbs-ft of torque (see Figure 4).

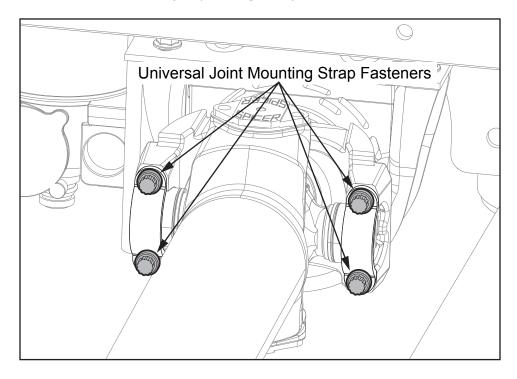
Figure 5, ACX / DC vehicles universal joint fasteners

7. For all affected ACX and DC vehicles. Locate the 4 universal joint mounting strap fasteners and tighten to 125 Lbs-ft of torque (see Figure 5).

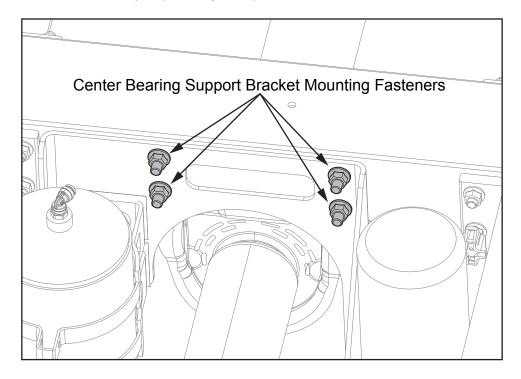
Figure 6, DC vehicles, center bearing support bracket

8. For DC vehicles. Locate the 4 center bearing support bracket mounting fasteners and tighten to 90 Lbs-ft of torque (see Figure 6).
