PREVOST

**SAFETY
RECALL**

SR23-305

DATE :	June 2023	SECTION :	18 BODY
SUBJECT:	FLIP-UP SEAT PIVOT BOLTS

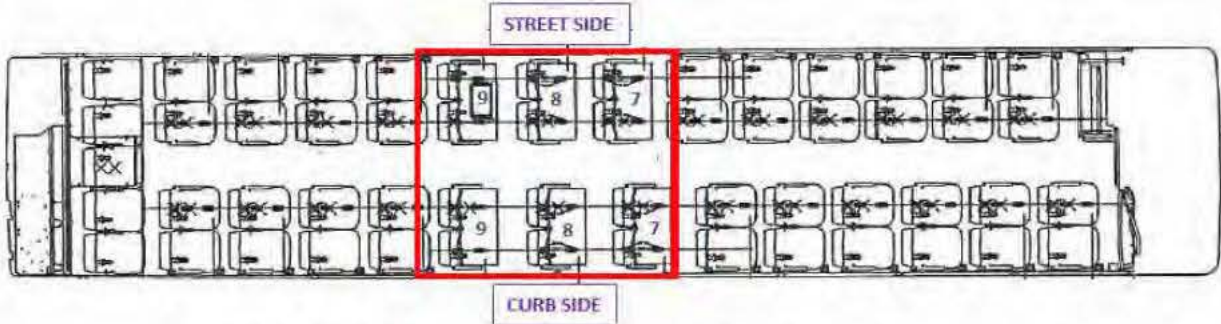
On the vehicles covered by this campaign, the two bolts securing the flip-up seat cushions to the seat frames can loosen and disengage, allowing the seat cushions to come loose.

VEHICLE SEAT CONFIGURATION SHOWING FLIP-UP SEATS POSITION

Therefore on the affected vehicles, threadlocker adhesive (Loctite) must be applied to all seat cushion bolts (see reference picture below).

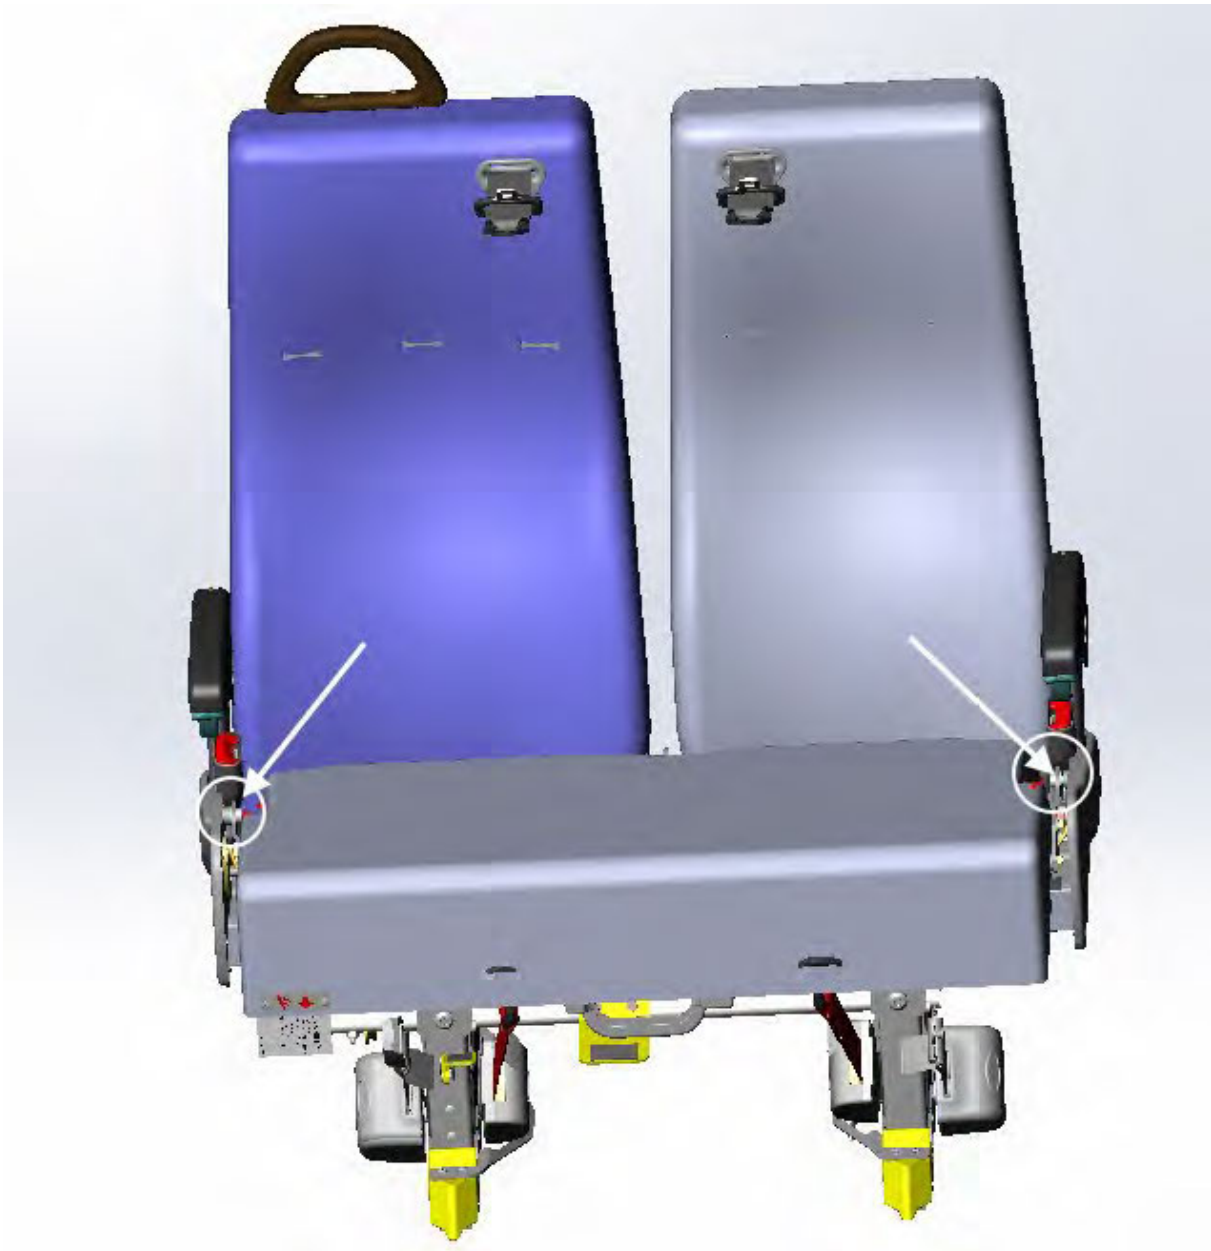
AMSECO SOLUTION : Add high-strength threadlocker (red) to flip-up pivot bolts.

- Remove the pivot bolt.
- Add a good quality, high-strength thread-locking adhesive to the bolt threads.
- Reinstall the pivot bolt (tighten firmly).
- Repeat for all seat bolts concerned.
