PREVOST

SAFETY RECALL

SR23-304

DATE :	June 2023	SECTION :	18 BODY
SUBJECT:	Missing Weld on Passenger Flip-Up Seat

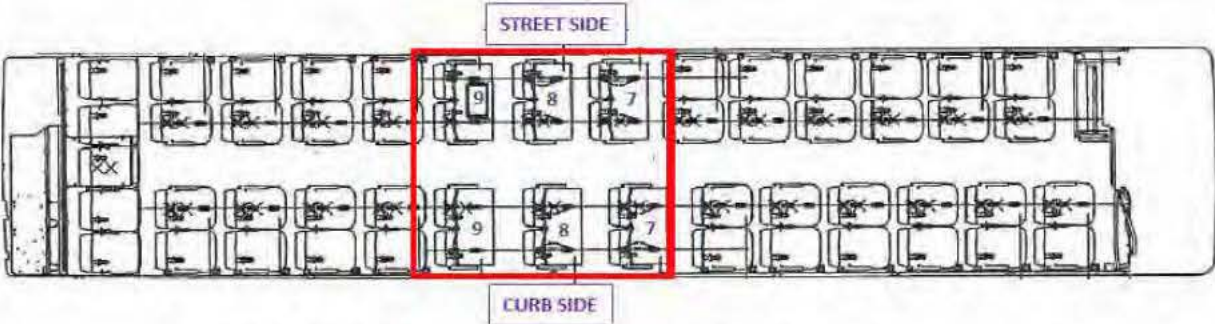
VEHICLE SEAT CONFIGURATION SHOWING FLIP-UP SEATS POSITION

On the vehicles affected by this recall, some of the foldable passenger seat frames may have been improperly welded.

Therefore, all vehicles must have their folding seats inspected and their frames replaced as necessary following the inspection procedure provided below.

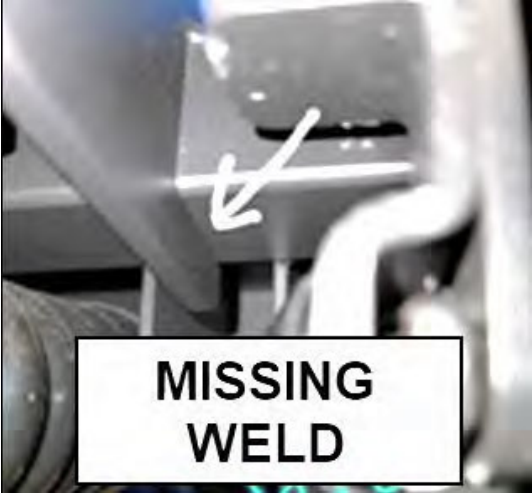
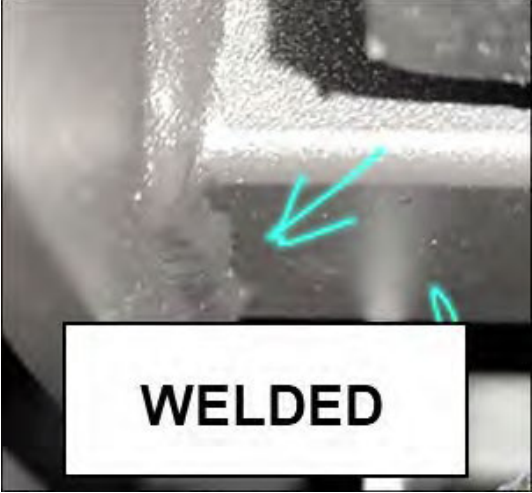
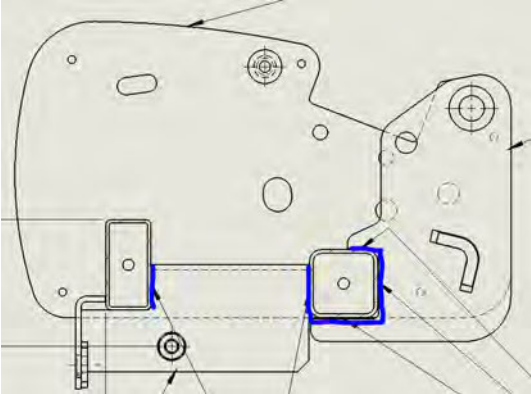
- 1. The tubes, brackets, and center pivot are to be welded as shown below in blue. The weld will be on both sides of the recline bracket and center pivot.

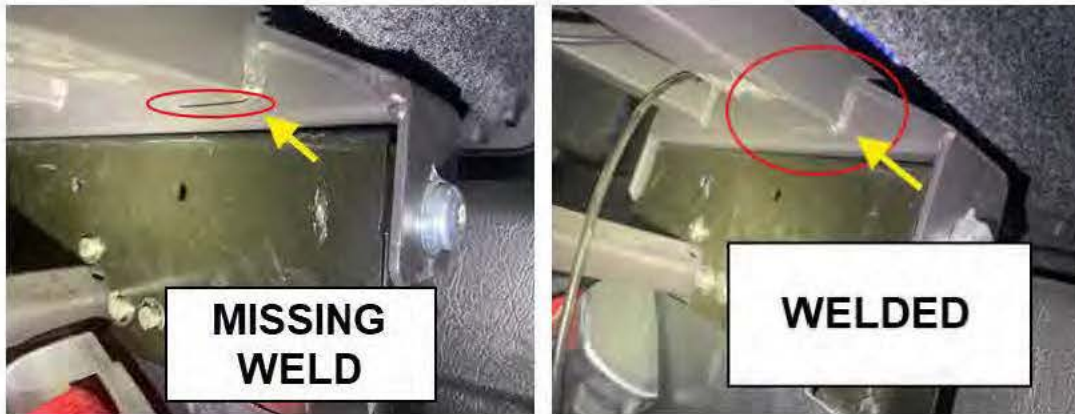
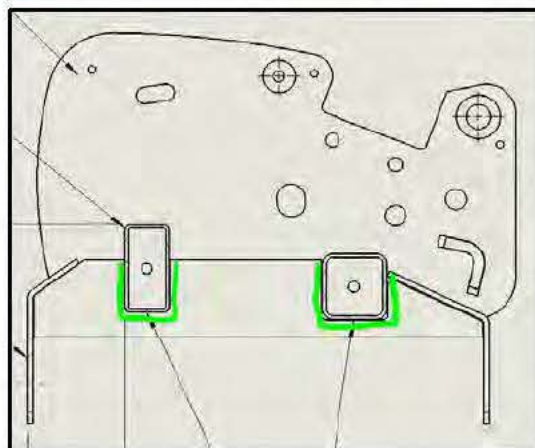
2. The tubes and brackets are to be welded as shown below in green. The weld will be on both sides of the pedestal brackets.
