## Recall Service Bulletin RSB23-650-001

- DATE:** 7/11/2023
- APPLIES TO:** This service bulletin applies to certain 2018 through 2021 model year, Gladiator and Metro Star model emergency response pumpers built between November 2017 and October 2021.
- NHTSA/TC Id:** 23V-389
- CONDITION:** The retaining pin on the hoist ring hinge pin may not be in place and could allow the hinge pin to come out during unloaded condition.
- CORRECTION:** Inspect the hoist ring hinge pins and replace as necessary.
- LABOR ALLOCATION:** 0.5 hour per hoist ring
- CLASSIFICATION:** V3

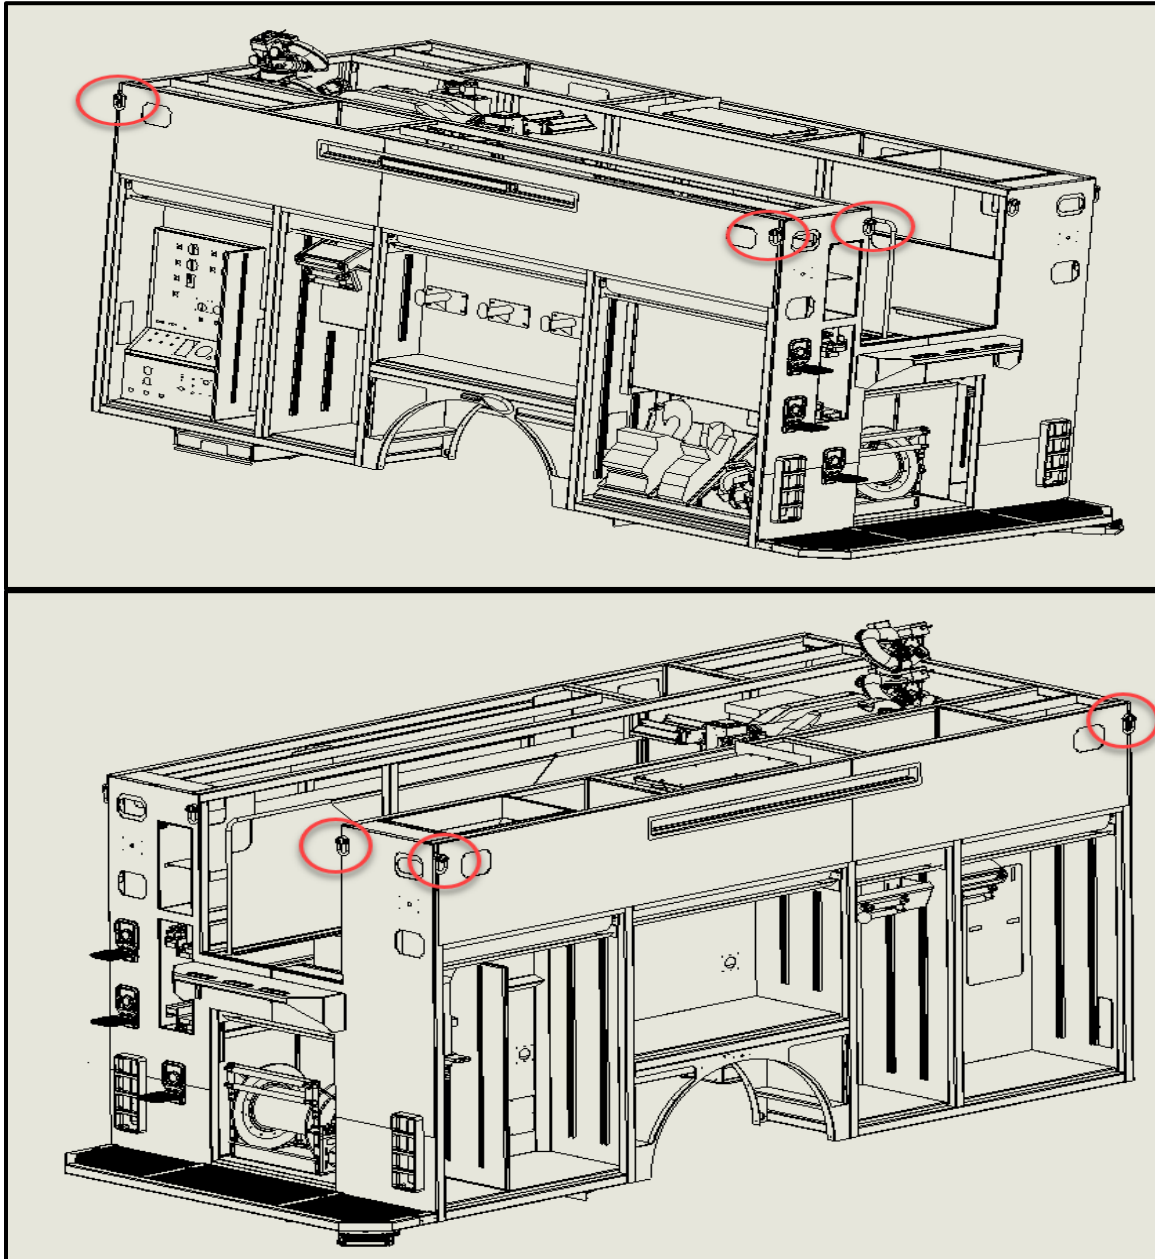
Hoist rings may be found at these potential locations.  
*(Not all lift points shown below are used on every truck)*
