On the vehicles affected by this recall, it is necessary to add a resistor on the RH + LH turn signals as well as RH + LH low beams electrical circuits to solve an issue affecting the front RH turn signal.

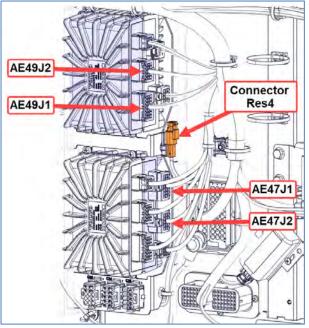
FIGURE 7: CONNECTOR RES4 LOCATION

3. On the dashboard electrical control panel, find connector RES4 located between MUX modules AE49 & AE47.

- 4. Detach connector RES4 from its support and secure on nearby harness using a nylon tie.
- 5. Secure connector C60 of *resistor harness 0600179* on the support in place of connector RES4.
