PREVOST

**SAFETY
RECALL**

SR23-310

DATE :	August 2023	SECTION :	18 BODY
SUBJECT:	FLIP-UP SEAT PIVOT BOLTS

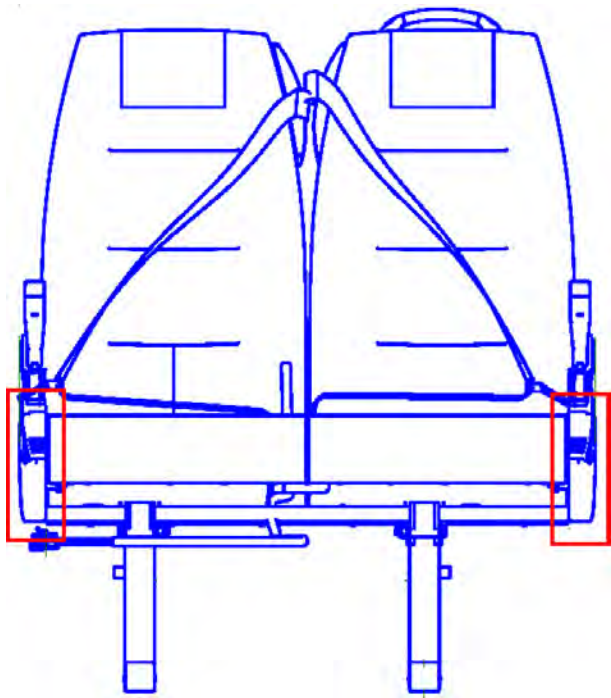
the bolt securing the passenger seat recline mechanism could loosen and disengage. In this condition, the seat's reclining function is inoperative (inability to lock the seatback in the desired angle), and the seatback can move freely within its adjusting limits. It is to be noted that the concerned seats are equipped with occupant seat belts integrated in the seat back.

Bolts on both sides are covered by trim panels

Therefore on the affected vehicles, thread locker must be added and the seat recline mechanism bolts must be adequately torqued.
