PREVOST

**SAFETY
RECALL**

SR23-310A

DATE :	August 2023	SECTION :	18 BODY
SUBJECT:	SEAT RECLINE MECHANISM PIVOT BOLTS

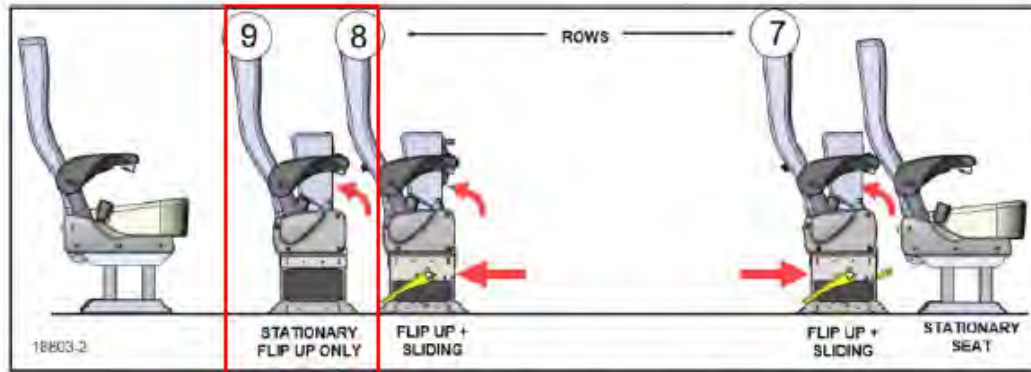
Only the stationary flip up seat (see seat #9) are concerned by this issue (distinct recline mechanism design).

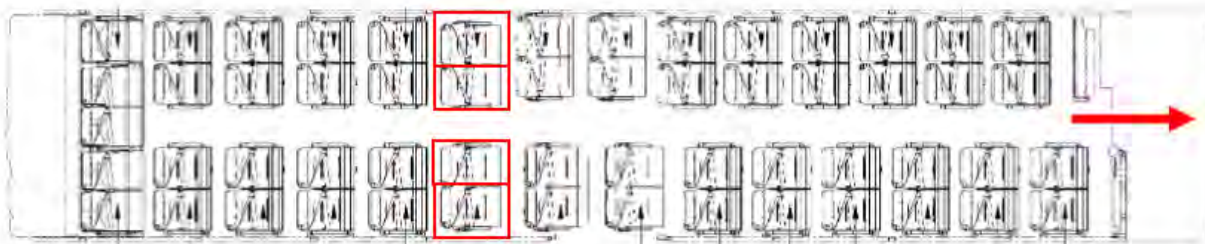
There are 4 potentially defective seats in each vehicle (stationary flip up seats – see seat #9 above).
Each seatback is secured with 1 bolt => 4 potentially concerned bolts per vehicle.

USSC SOLUTION : Add high-strength threadlocker (red) to flip-up pivot bolts.

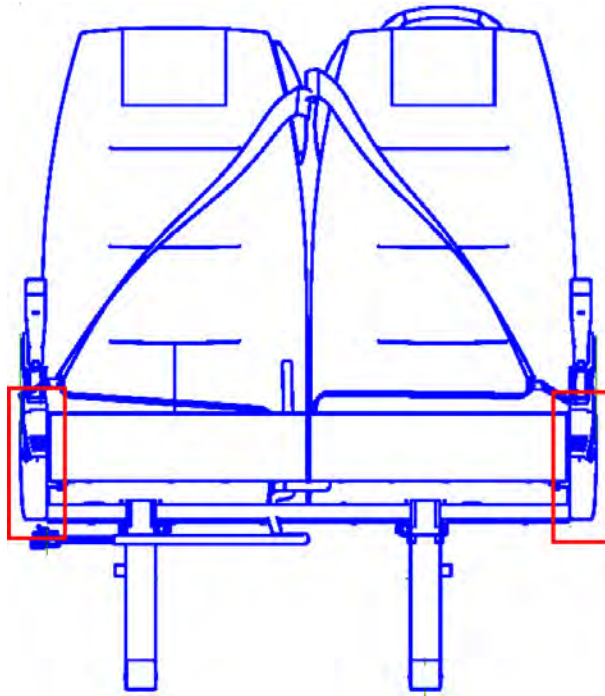
Bolts on both sides are covered by trim panels

- Remove the trim panel.
- Remove the pivot bolt.
- Add a good quality, high-strength thread-locking adhesive to the bolt threads.
- Reinstall the pivot bolt (tighten firmly).
- Reinstall the trim panel.
- Repeat for all seat bolts concerned.
