Service Bulletin - June 2023

SAF Tire Pilot Plus™ (TPP) Inflation System

Tire Pilot Plus Safety Concern

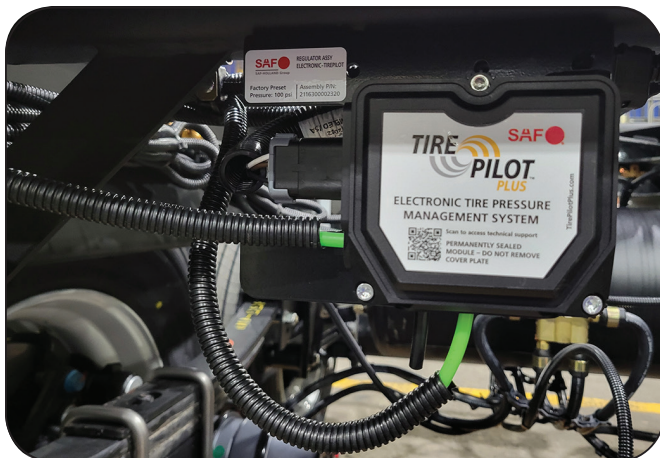
Figure 1

Tire Pilot Plus (TPP) system produced on trailers after November 2022 with the electronic regulator assembly have been determined under specific conditions to slowly deflate the trailer tires.

1. Check the trailer build date on the VIN tag. If it was manufactured November 2022 or later, the trailer could be in the target group, but needs to be confirmed to have the electronic regulator assembly installed.
2. **Figure 1** illustrates the new electronic regulator that will need to be disabled. Location is on the front cross-member for a sliding suspension.
3. Before performing any maintenance on the trailer, set the parking brake and block the tires.
