PREVOST

**SAFETY
RECALL**

SR23-42

DATE :	November 2023	SECTION :	06 ELECTRICAL
SUBJECT:	RETIGHTEN POWER RELAY R29 CABLE NUTS

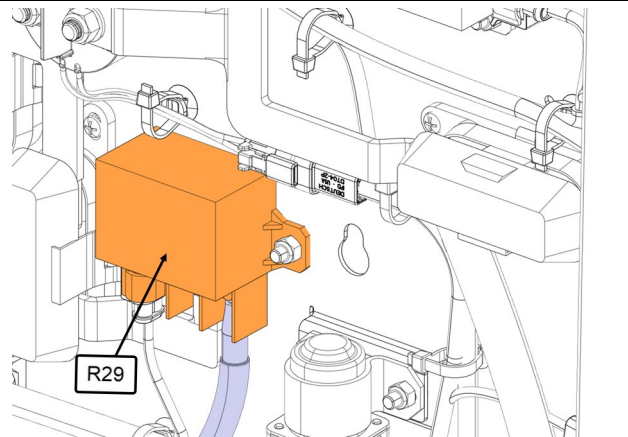
5. Locate the power relay **R29**.

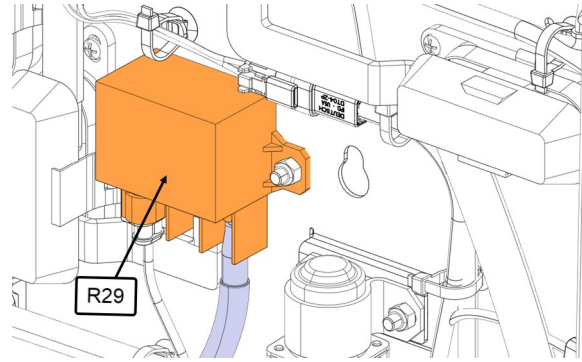
5. Locate the power relay **R29**.

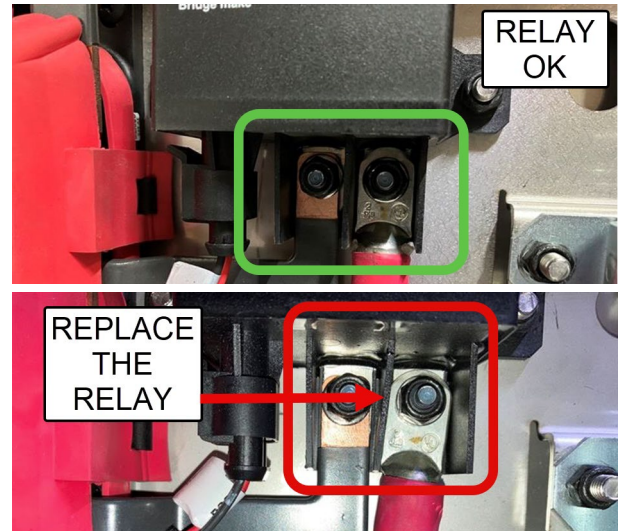
6. Inspect the power relay.

- If the relay connection divider is not damaged, go to the next step.
- If the relay connection divider is damaged see relay replacement section.
- If you do not have a new relay on hand, continue the procedure to ensure the quality of the assembly.

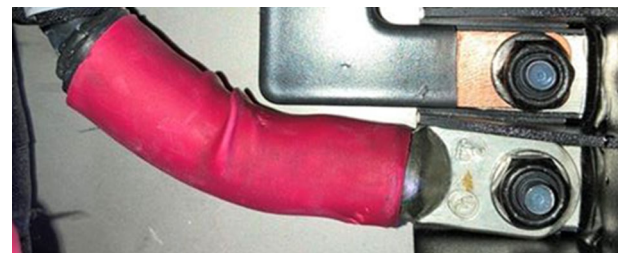
7. Inspect cable shrink tubing.

If shrink tubing of the cable is damaged, replace it with a new shrink tubing 561755.
