6/12/2023 – Examples of required attachments update

Safety Recall – 2022-2023 CX-30 AND 2023 CX-50 Brake Pedal Travel May Increase

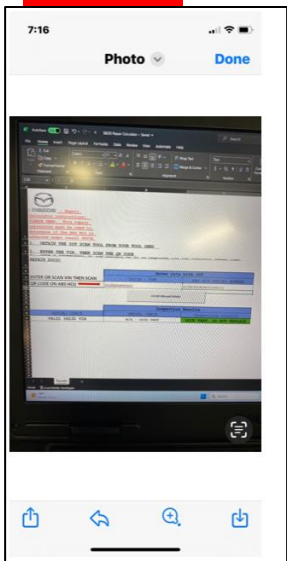
NO GOOD: Too Small
