SAFETY RELATED RECALL

Global Recall Action
Number: N964

Subject: Raised Air Intake Detachment	Publication No.: N964
	Model: Defender (LE)
	Model Year: 2020 - 2025
	Date of Issue: 11 February 2025

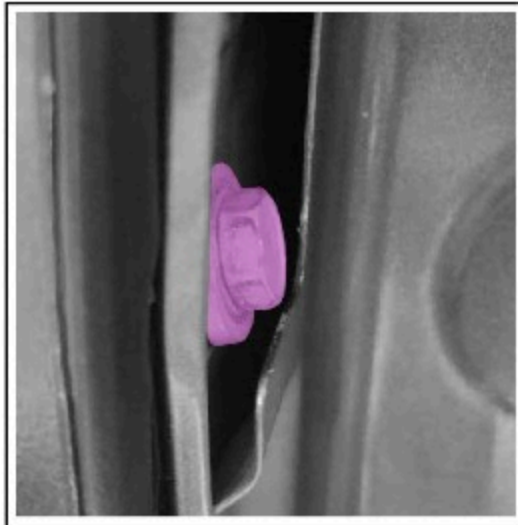
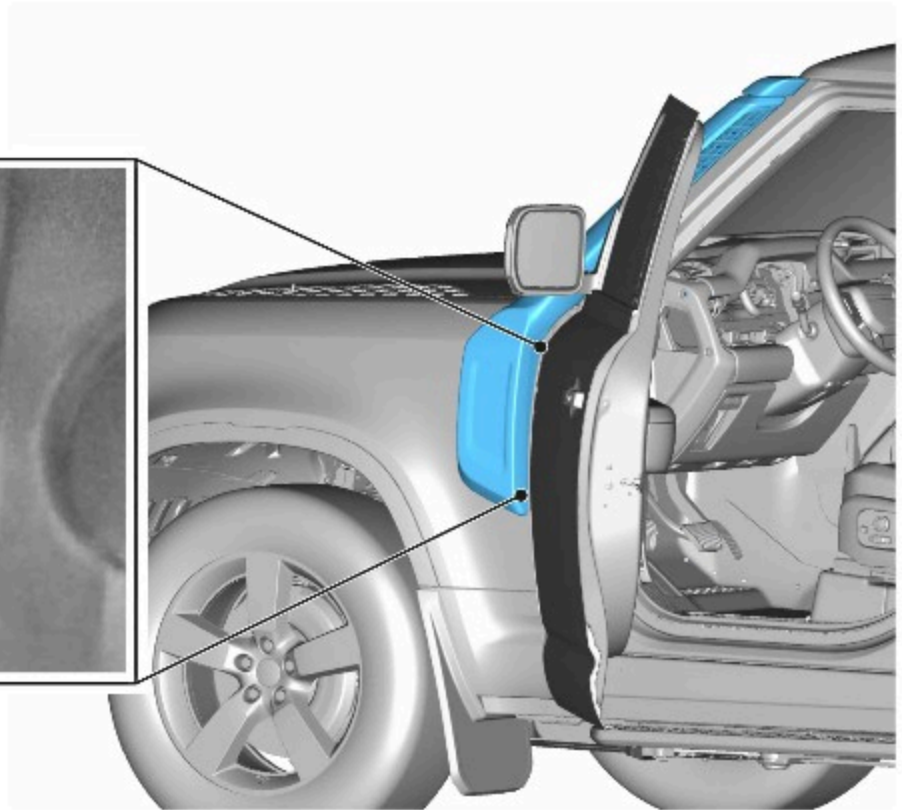
E377866

- If the raised air intake is fastened with bolts in the locations shown, this raised air intake is part number **VPLEP0435** which **is not** affected by this campaign, **no further action is required. Do not** continue with this campaign.
- If the raised air intake is not fastened with bolts, this raised air intake is part number **VPLEP0543** which **is** affected by this campaign, continue to **Service Instruction**.

1. Open the front left door, using an extendable mirror inspect the inside of the left fender in the locations shown in the illustration.
