Recall Campaign Bulletin

Campaign No. 2024030001, March 2024

SUBJECT: **Model E-Class, CLS, and AMG GT 4-Door (213, 257, and 290 platform)
Model Year 2021-2023**

Check 48V Ground Connection

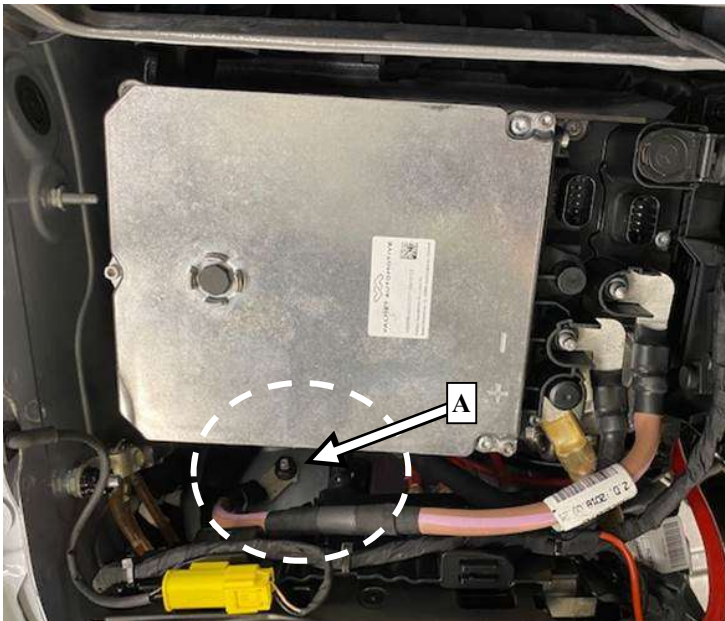
Figure 1, Top view with removed air duct segment

3. Perform visual check of ground point of 48 V battery (**A, Figure 1**) for thermal damage. If no damage is visible, disconnect the ground point.

i Ensure routing without chafe marks (**use Figure 1 for orientation**).

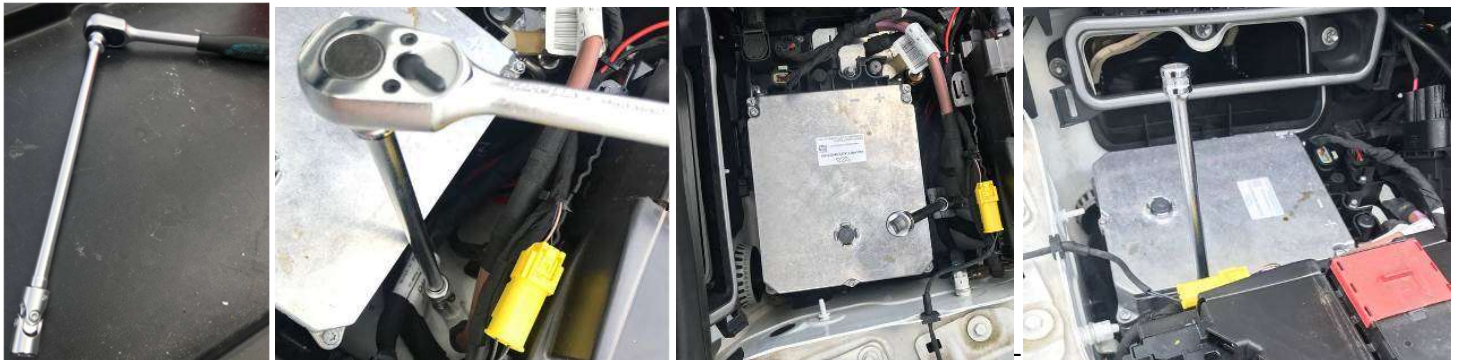
Figure 2, Accessibility of ground screw connection of 48 V battery (W106/3)

i The nut of the ground screw connection can be accessed with an extension and swivel socket. (**Figure 2**).

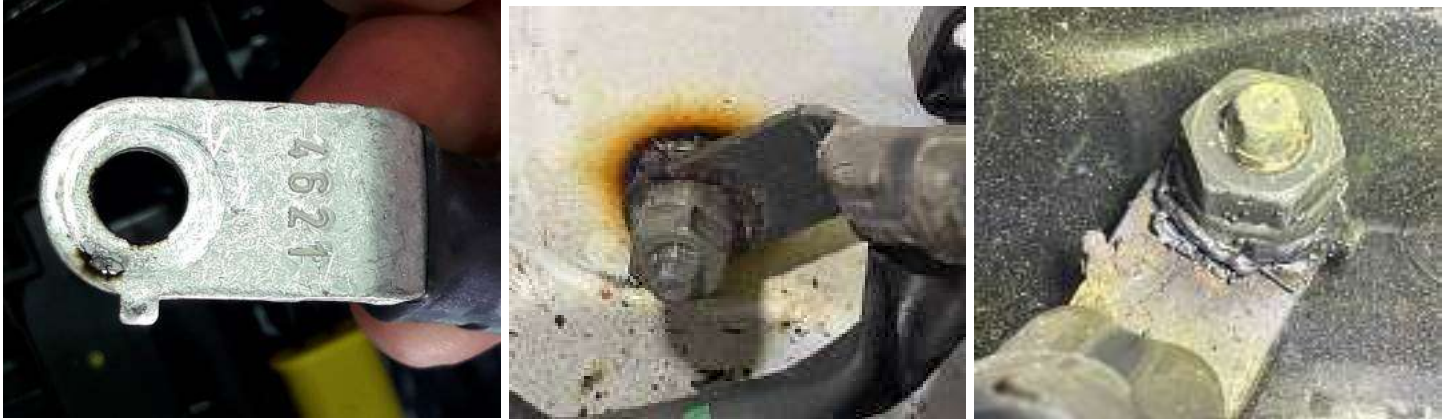
4. Check the contact surfaces of the bolts, cable lug, and nut for damage. **(Figure 3)**

- a. Thermal damage found in area of 48 V battery ground point (traces on contact surface of nut/cable lug/bolt): Carry out **Work Procedure**.
- b. No damage present. Assemble in reverse order: **End Measure**.

Figure 3, examples of thermal damage (e.g. evidence of arcing, scorch marks, welding of the nut/cable lug/bolt), **not OK** pictures

Nm Torque ground line to ground bolt **16 Nm**.

1. Replace 48 V battery ground line and replace M8 nut; install new bolt if necessary; remove 48 V battery if necessary.
