TO: Mercedes-Benz Dealer Principals, General Managers, Sales Managers, Service Managers, Parts Managers	FROM: Gregory Gunther, Senior Manager, Vehicle Compliance and Analysis, Engineering Services
RE: <b>Recall Campaign Launch Notification</b> <b>Rework the Accelerator Pedal Module Bracket</b> <b>MY24 GLE (167 platform)</b>	DATE: March 22, 2024

Campaign No. 2024030009, March 2024

SUBJECT: **Model GLE (167 platform)**  
**Model Year 2024**

## **Rework Accelerator Pedal Module Bracket**

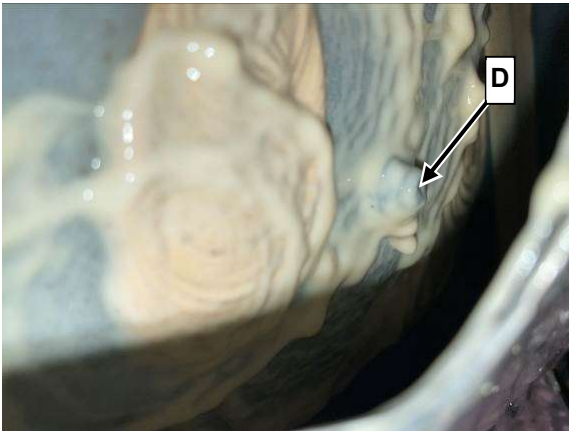
**Figure 9** (rivet D, view from below with cavity preservation)

4. Clean the riveted area and apply **cavity preservation (A 000 986 32 01 09)** to both locations shown in **Figures 9 and 10**.
