# SAFETY RELATED RECALL

Global Recall Action  
Number: N871

| <b>Right Side Lower A-Pillar Bolt</b> | Publication No.: N871 |
| | Model: Discovery Sport (LC) |

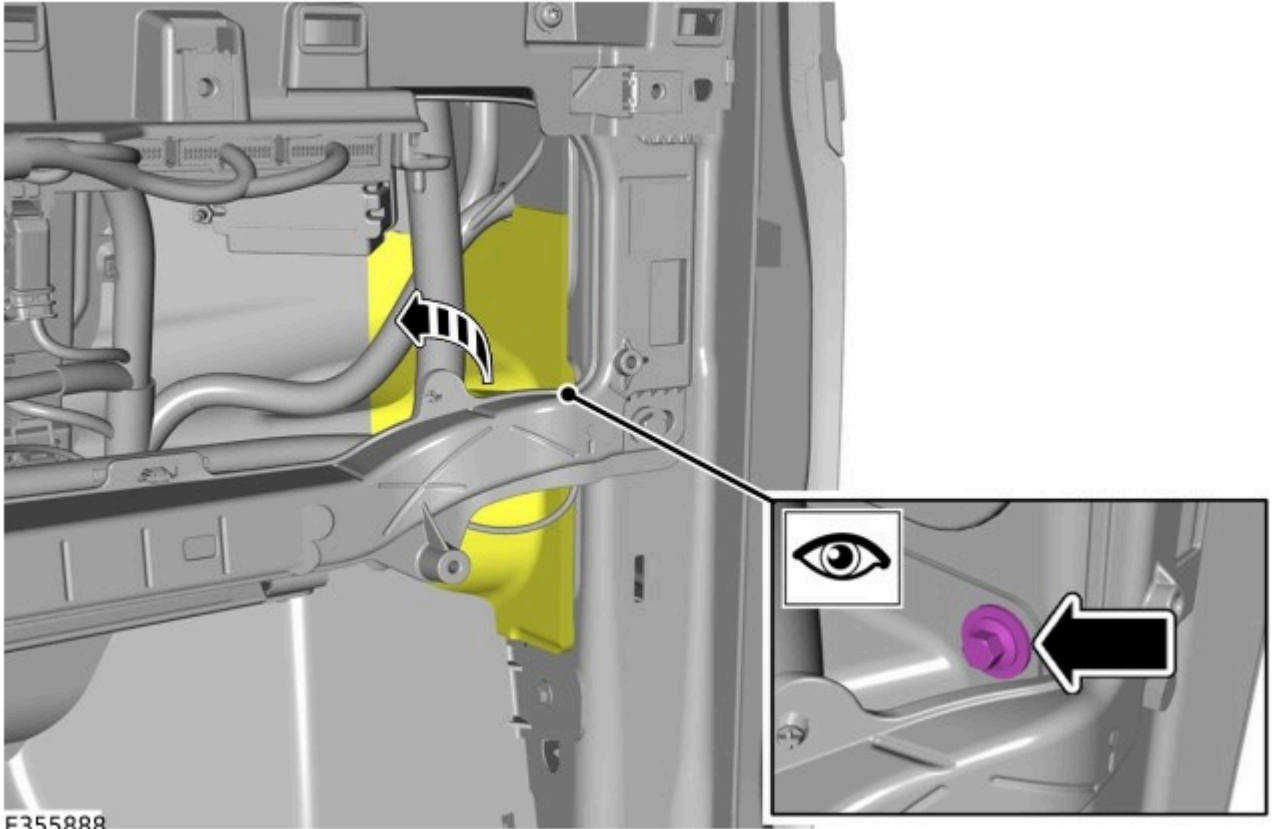
E355888

3. Reposition the **Noise, Vibration and Harshness (NVH)** material to access the lower A-pillar bolt.

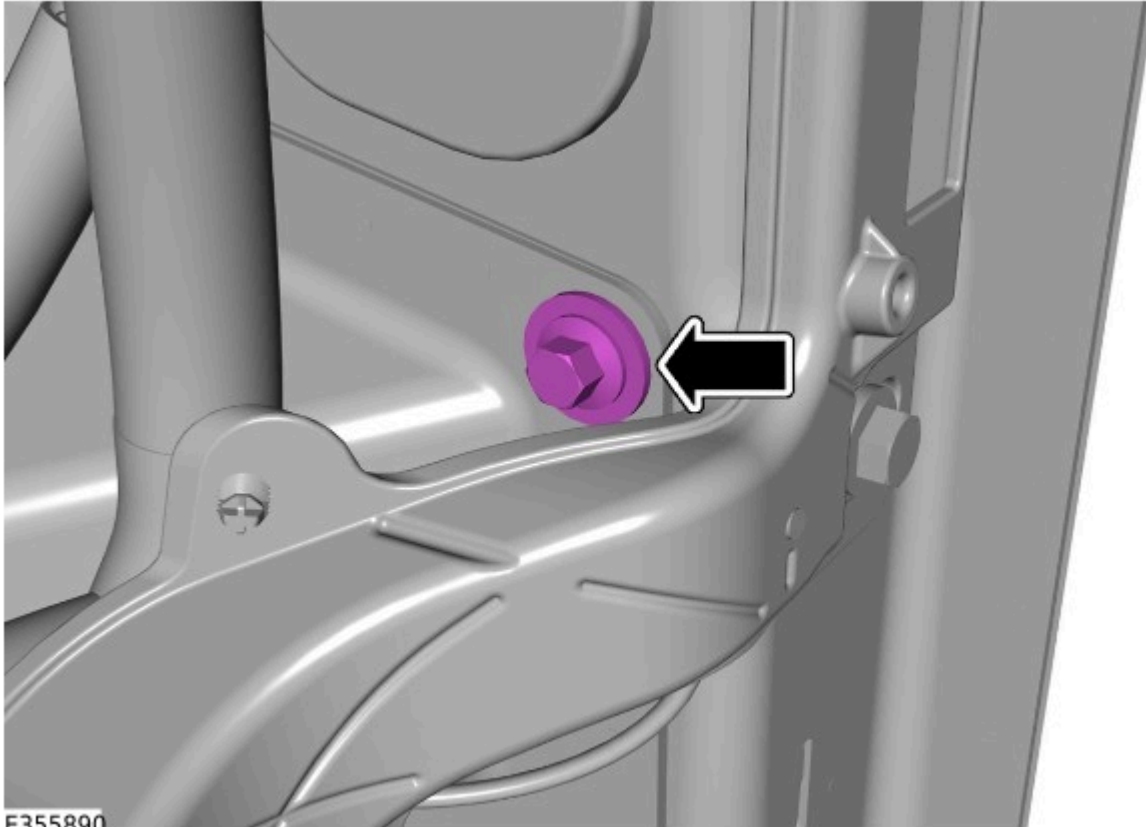
E355890

A concern has been identified where the right side lower A-pillar bolt may not have been fastened to the correct torque on some body shells. For 7 seat and Plug-in Hybrid Electric Vehicle (PHEV) specification vehicles it is possible that the body structure may not perform as intended in certain crash modes.

To tighten the lower A-pillar bolt a 1/4 drive socket, 1/4 drive extension, 1/4 drive to 3/8 drive adapter and 3/8 drive torque wrench is required.

Tighten the lower A-Pillar bolt.

- Torque: **24 Nm**

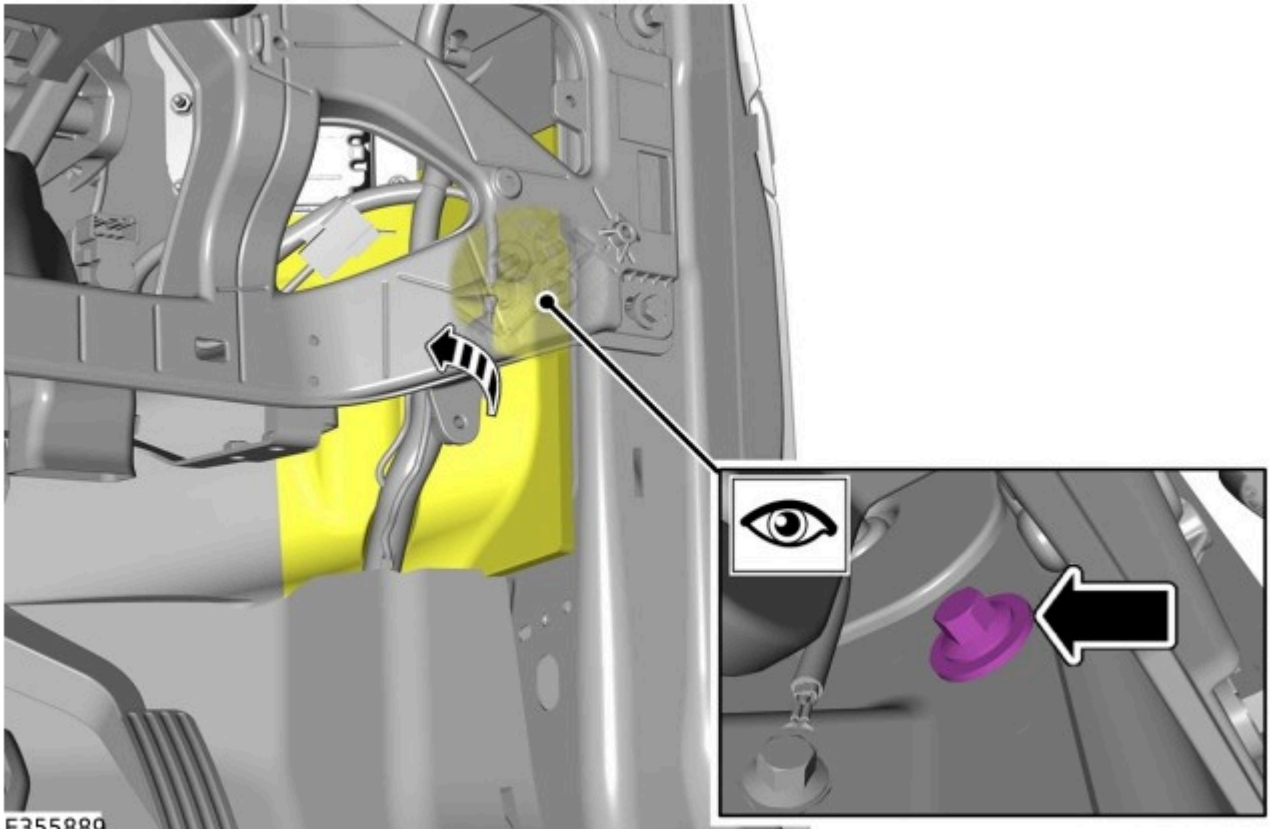
3. Reposition the [NVH](#) material to access the lower A-pillar bolt.
