TO: Mercedes-Benz Dealer Principals, General Managers, Sales Managers, Service Managers, Parts Managers	FROM: Anthony Washington, Senior Manager, Regulations and Certifications
Re: Launch Recall Campaign Notification Model: Sprinter (907) Model Year: 2023 Inspect Main Wiring Harness Routing	DATE: April, 2024

IMPORTANT RECALL CAMPAIGN INFORMATION

Campaign No. :	Campaign Desc. :	Inspect Main Wiring Harness Routing
2024030019	VS3BEFHAU	
<p>This is to notify you of a Recall Campaign to inspect the main wiring harness routing on approximately 828 MY 2023 Mercedes-Benz Sprinter Vans. The recall campaign will be visible on the www.safercar.gov website and may generate questions from customers. All affected VINs will be flagged as "OPEN" in VMI and cannot be sold.</p>		
Background		
Issue	<p>Mercedes-Benz AG ("MBAG"), the manufacturer of Mercedes-Benz Sprinter vehicles, has determined that on certain Sprinter vehicles, the routing of the main wiring harness might not meet specifications. In this case, the wiring harness might contact the drive shaft, and chafe Over time, this could result in a short circuit of various wires in the harness. Depending on the affected wire, a risk of fire,

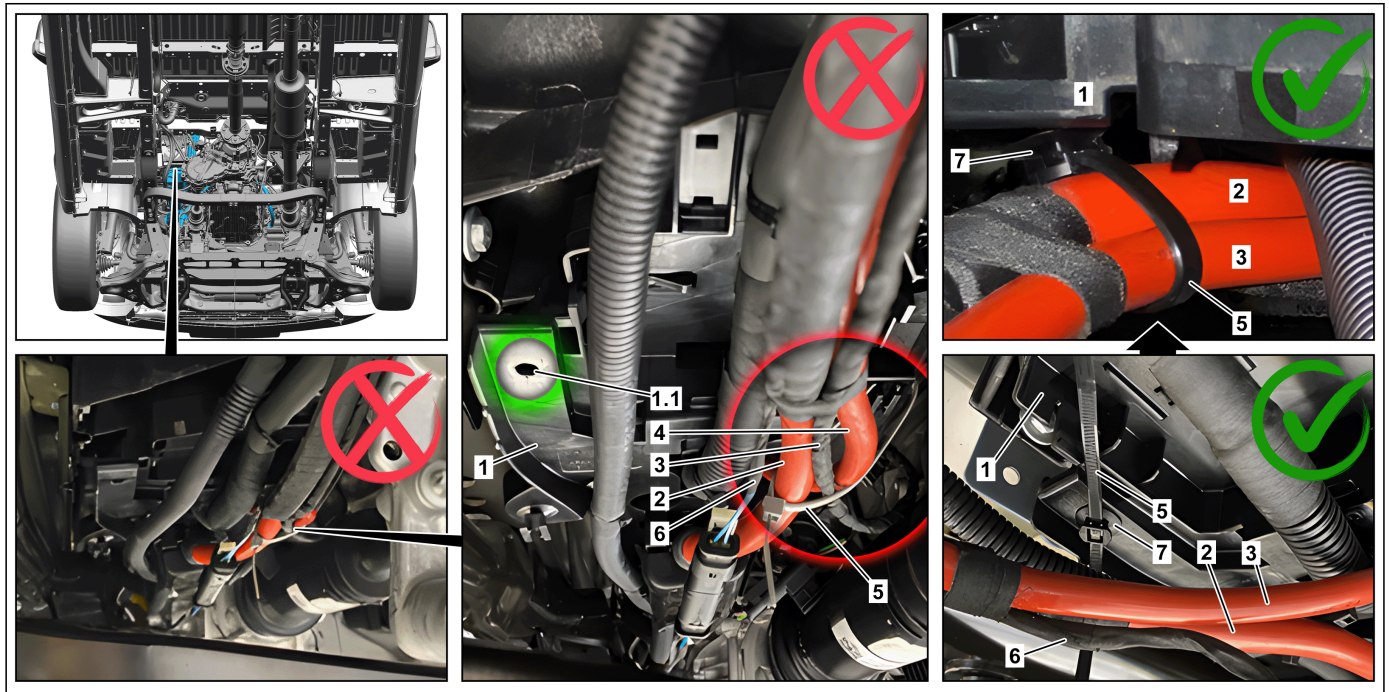
D54.18-A059-79

3	Check routing of wiring harness for starter-alternator.	<p>i</p> <p>For correct routing, see picture 2: Attach wiring harness bundle with cable tie (5) and retaining clip (7) to holder (1). To do so, clip retaining clip (7) into hole (1.1) (picture 1).</p> <p>For incorrect routing, see picture 1 and 2:</p> <ul style="list-style-type: none"> - Cable tie attached to sheet metal (picture 2, left) - Cable tie (5) attached to holder (1) on wrong side (picture 1, center) - Wiring harness fastened so that electric lines run too close to propeller shaft (picture 1, center) <p>If alternator line (2) or electric steering line (4) is damaged,</p> <p style="text-align: center;">↓</p> <p>replace damaged alternator line (2) and/or electric steering line (4). Repair is not permissible.</p> <p>If electric lines (3, 6) are damaged,</p> <p style="text-align: center;">↓</p> <p>repair respective damaged electric line (3, 6).</p> <p>If mount is not correct,</p> <p style="text-align: center;">↓</p> <p>continue with operation step 4.</p>

If alternator line (2) is damaged: Order main wiring harness with item number **A 907 540 84 65** and branch off required new alternator line (2) from wiring harness.

Correct mount of wiring harness			
4	Cut cable tie (5).	<p>i</p> <p>Replace cable tie (5).</p>	
5	Position alternator line (2), electric steering line (4) and electric lines (3, 6) correctly and fasten.	<p>ⓘ</p> <p>Do not kink any electric lines and ensure that they are routed without any chafing. This prevents any damage.</p> <p>i</p> <p>For correct routing, see picture 2: Attach wiring harness bundle with new cable tie (5) and retaining clip (7) to holder (1). To do so, clip retaining clip (7) into hole (1.1) (picture 1).</p>
