Recall Campaign Bulletin

Campaign No. 2024040002, April 2024

SUBJECT: **Model GLE/GLS (167 platform)**
Model Year 2019 – 2024

Check 48V Ground Connection on Passenger Seat

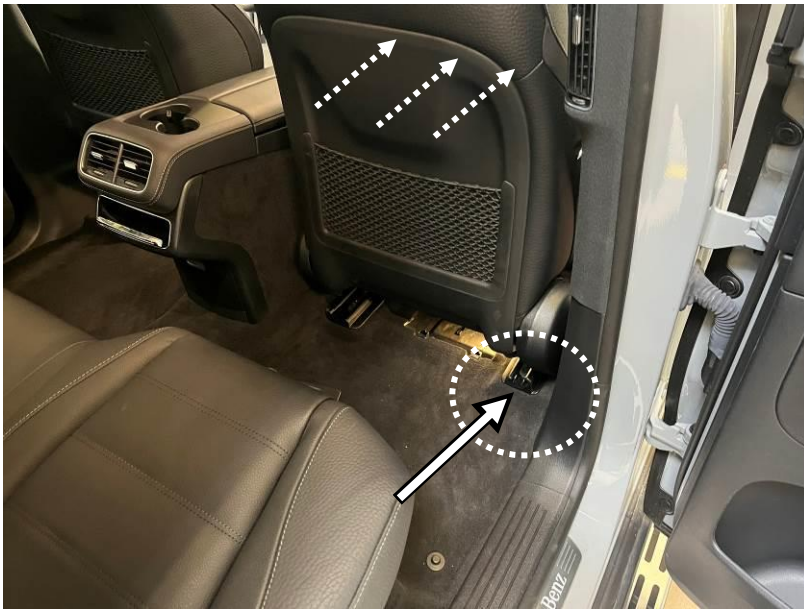
Figure 1

1. Place vehicle key outside of radio range.
2. Unscrew front passenger seat and tilt forward slightly (**Figure 1**).
 - Nm** Screw, front seat to vehicle floor: **50 Nm**.
 - i** The front seat remains in the vehicle with the wiring harness connected.
 - i** For basic data, see **AR91.10-P-1000ME**.

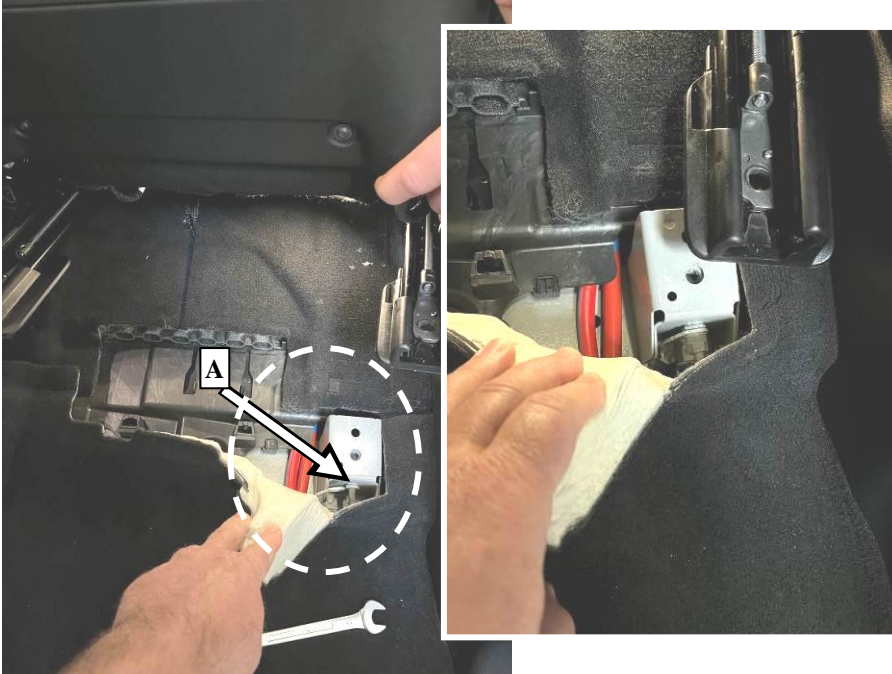
Figure 2

3. Lift floor covering above ground point "W106/1" (**Figure 2, A**) for 48 V on-board electrical system battery.

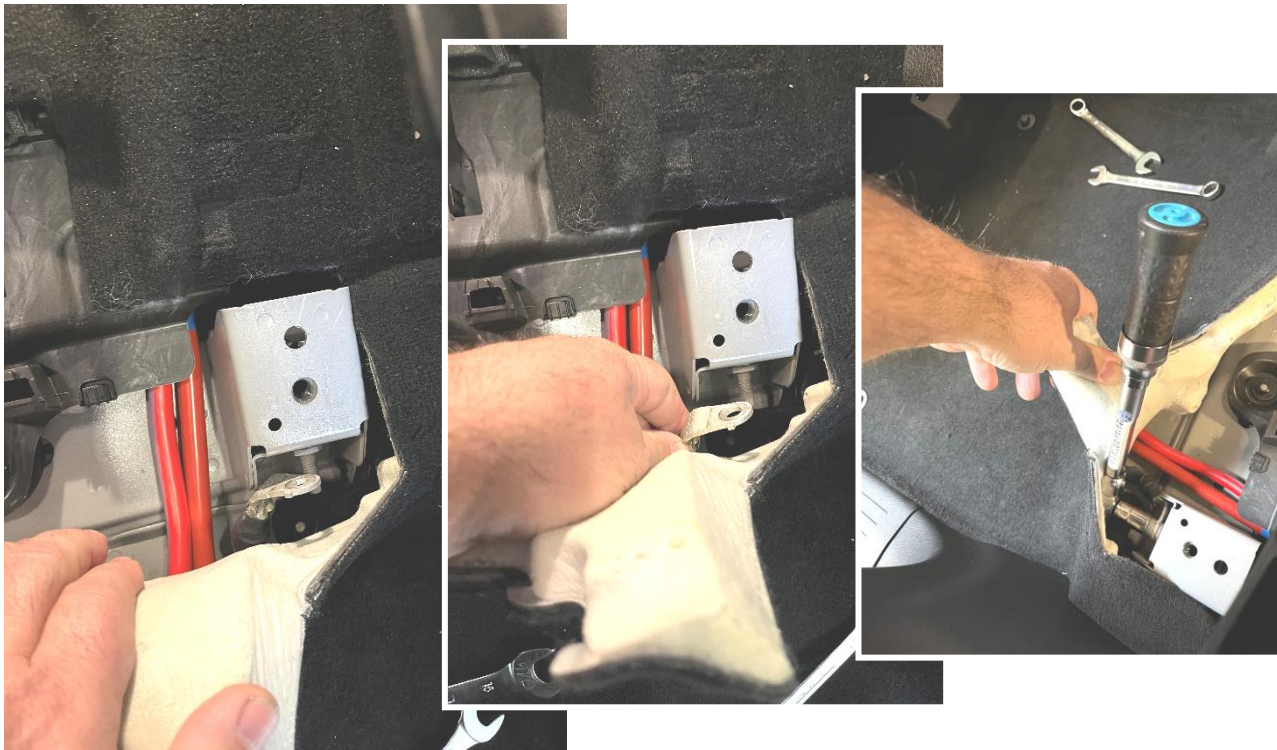
Figure 3

4. Disconnect and check screw connection of electrical wiring harness of 48 V on-board electrical system battery of "W106/1" ground point on body (**Figure 3**).

1. Connect electrical wiring harness of 48 V on-board electrical system battery to "W106/1" ground point.
 - Nm** Torque of screw connection, electrical wiring harness to "W106/1" ground point: **20 Nm**.
 - Nm** Torque of screw connection, ground harness to 48 V on-board electrical system battery: **16 Nm**.
 - i** During installation of the electrical wiring harness to the "W106/1" ground point, ensure the contact surface is clean and free of damage at connection points.
 - i** **Never pull on the cable for testing purposes after the repair! If the line was pulled, the ground point must always be retightened, even if there is no damage.**
2. Assemble in reverse order.
3. Connect XENTRY Diagnosis.
4. Perform quick test and clear fault memory.
5. Disconnect XENTRY Diagnosis.

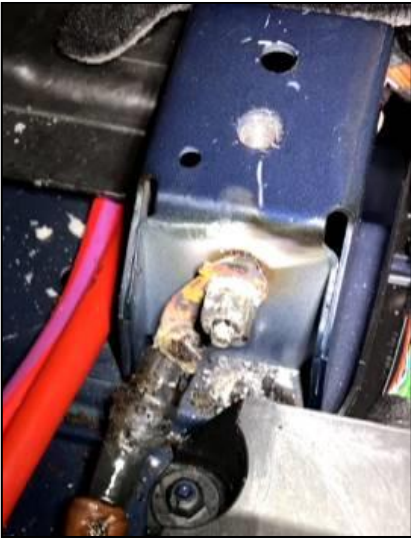
Figure 4 (not OK image)

i Inspect ground connection for traces of thermal overload or damage (**Figure 4**).

A. If **traces of thermal overload or damage** are **present** on the wiring harness at the "W106/1" ground point:

- Carry out **Work Procedures A and B.**

1. Replace electrical wiring harness from "W106/1" ground point to 48 V on-board electrical system battery (**Figure 5**).

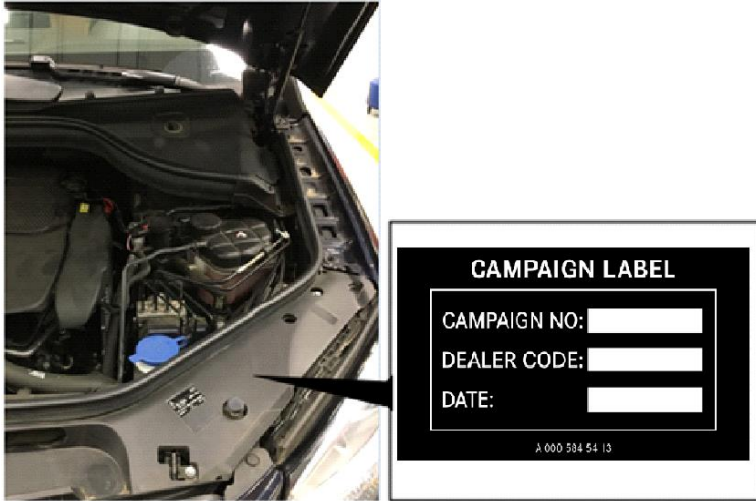
Figure 1

Apply Proof of Correction Label (A 000 584 54 13) to area identified in **Figure 1**. Fill in the blank areas of the label. The “Campaign No.” for the California Proof of Correction is unique and must be entered as such (24V207), your “Dealer Code”, and the “Date” of the repair, using a black permanent marker.
