TO: Mercedes-Benz Dealer Principals, General Managers, Sales Managers, Service Managers, Parts Managers	FROM: Gregory Gunther, Senior Manager, Vehicle Compliance and Analysis, Engineering Services
RE: Recall Campaign Launch Notification Check 48V Ground Connection under Passenger Seat MY19-24 GLE and GLS (167 platform)	DATE: April 12, 2024

Campaign No. 2024040002, April 2024

SUBJECT: **Model GLE/GLS (167 platform)**
Model Year 2019 – 2024

Check 48V Ground Connection on Passenger Seat

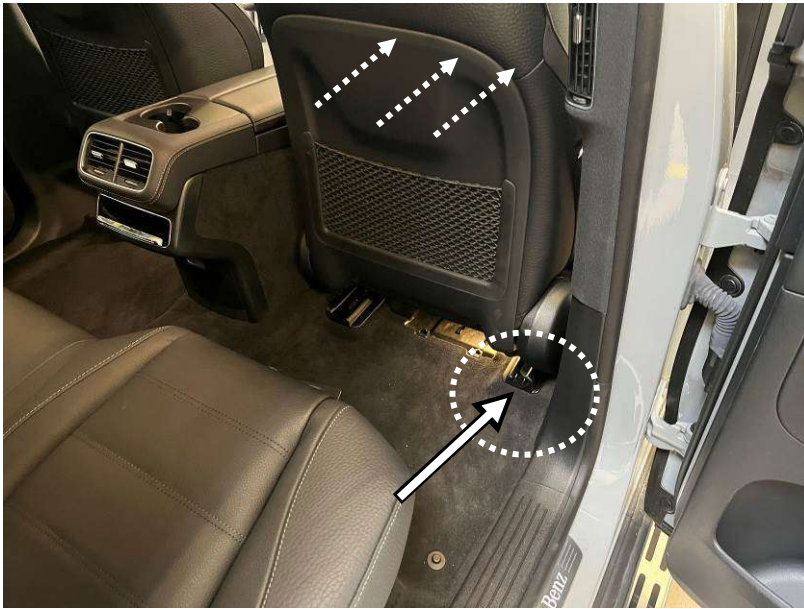
Figure 1

1. Place vehicle key outside of radio range.
2. Unscrew front passenger seat and tilt forward slightly (**Figure 1**).
 -

Screw, front seat to vehicle floor: **50 Nm**.
 -

The front seat remains in the vehicle with the wiring harness connected.
 -

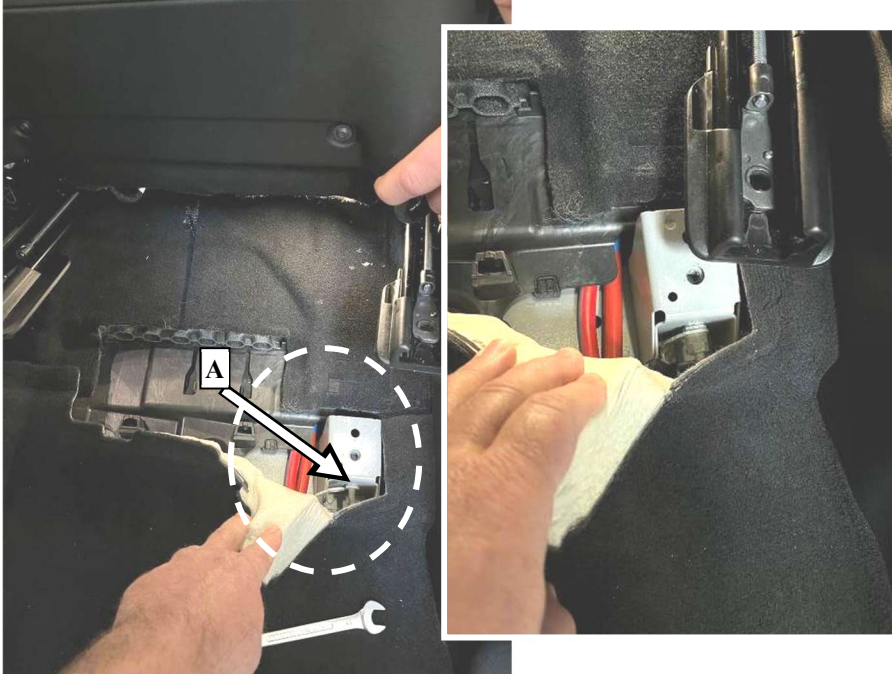
Figure 2

3. Lift floor covering above ground point "W106/1" (**Figure 2, A**) for 48 V on-board electrical system battery.

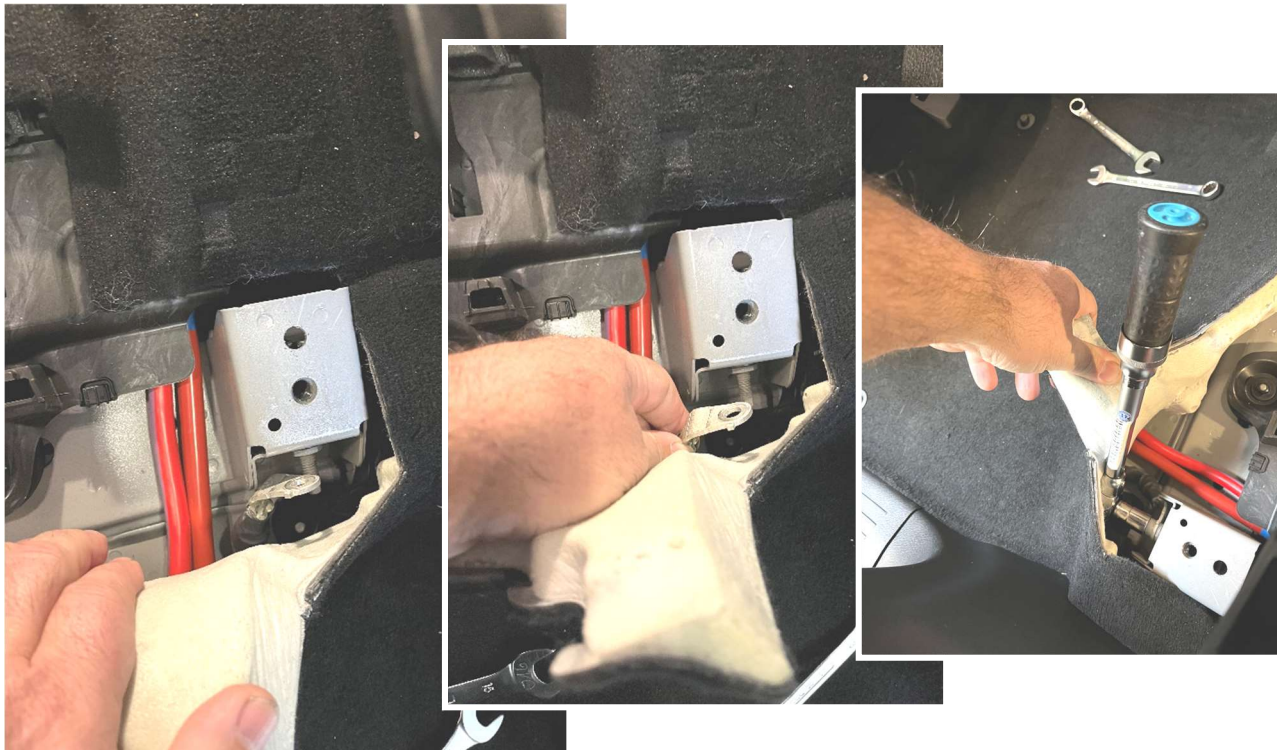
Figure 3

4. Disconnect and check screw connection of electrical wiring harness of 48 V on-board electrical system battery of "W106/1" ground point on body (**Figure 3**).

Torque of screw connection, electrical wiring harness to "W106/1" ground point: **20 Nm**.
 -

Torque of screw connection, ground harness to 48 V on-board electrical system battery: **16 Nm**.
 -

During installation of the electrical wiring harness to the "W106/1" ground point, ensure the contact surface is clean and free of damage at connection points.
2. Assemble in reverse order.
3. Connect XENTRY Diagnosis.
4. Perform quick test and clear fault memory.
5. Disconnect XENTRY Diagnosis.

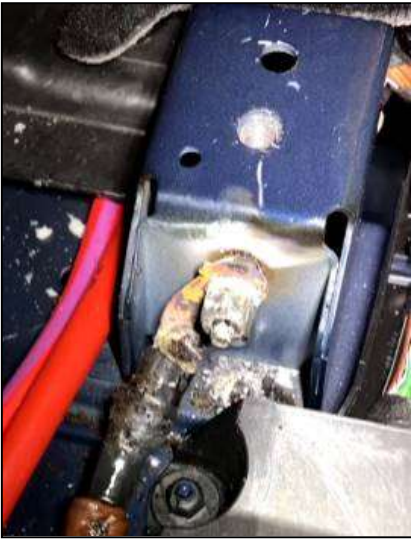
Figure 4 (not OK image)

Mercedes-Benz AG, the manufacturer of Mercedes-Benz vehicles, has determined that on certain MY 2019-2024 GLE and GLS (167 platform) vehicles, the 48V ground connection under the passenger seat might have become loose. In this case, the ground cable lug would not be secured correctly. Subsequently, the electric resistance of the connection might increase. In combination with the high electrical currents potentially flowing through this connection, the temperature in this area might increase. As a consequence, a risk of fire cannot be ruled out completely. An authorized Mercedes-Benz dealer will check the bolting of the ground connection on the affected vehicles and correct it, if necessary.

- i** Ensure 12 V on-board electrical system battery ground is still disconnected!
- i** Inspect ground connection for traces of thermal overload or damage (**Figure 4**).

- a. If **traces of thermal overload or damage** are **present** on the wiring harness at the "W106/1" ground point:
Carry out **Work Procedures A and B**.
NOTE: Capture photos of the damage present on the wiring harness to be included in Warranty claim
- b. If **traces of thermal overload or damage** are **not present** on the wiring harness at the "W106/1" ground point:
Carry out **Work Procedure B**.
