| RE: Recall Campaign Launch Notification Check 48V Ground Connection under Passenger Seat MY19-24 GLE and GLS (167 platform) | DATE: April 12, 2024 |

| Recall Campaign Launch Notification | | | April 12, 2024 |
|---|---|---|---|
| Campaign No. : | NHTSA ID/CA DMV : | Campaign Desc. : | Check 48V Ground Connection under Passenger Seat |

Campaign No. 2024040002, April 2024

Check 48V Ground Connection on Passenger Seat

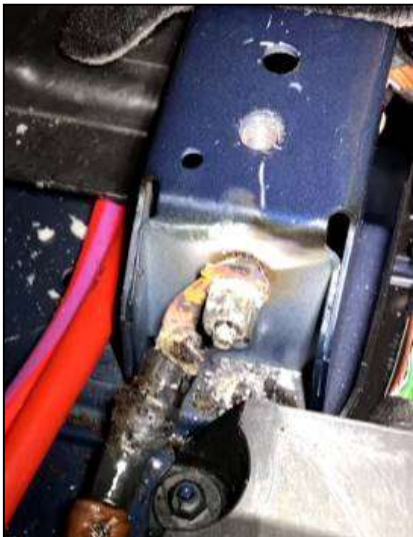
| Recall Campaign Launch Notification | | | April 12, 2024 |
|---|---|---|---|
| Issue | Mercedes-Benz AG, the manufacturer of Mercedes-Benz vehicles, has determined that on certain GLE and GLS (167 platform) vehicles, the 48V ground connection under the passenger seat might have become loose. In this case, the ground cable lug would not be secured correctly. Subsequently, the electric resistance of the connection might increase. In combination with the high electrical currents potentially flowing through this connection, the temperature in this area might increase. As a consequence, a risk of fire cannot be ruled out completely. | | |

i Inspect ground connection for traces of thermal overload or damage (**Figure 4**).

Figure 4 (not OK image)

- a. If **traces of thermal overload or damage** are **present** on the wiring harness at the "W106/1" ground point:
Carry out **Work Procedures A and B**.
NOTE: Capture photos of the damage present on the wiring harness to be included in Warranty claim
- b. If **traces of thermal overload or damage** are **not present** on the wiring harness at the "W106/1" ground point:
Carry out **Work Procedure B**.
