Campaign No. 2024040007, April 2024

SUBJECT: **Model E-Class (214 platform)**  
**Model Year 2024**

**Check Transmission Wiring Harness Routing**

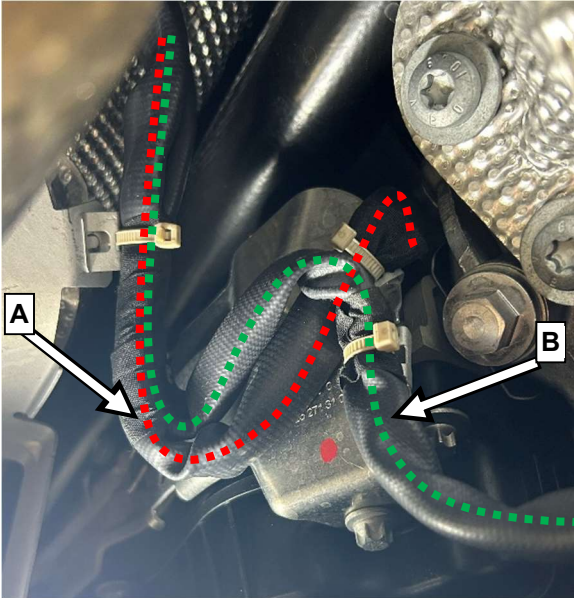
Figure 1 – **Red (A):** Power supply line  
**Green (B):** Signal wires

1. Check routing (**Figure 1**) and distance (**Figure 2**) between electrical wiring harnesses and the transmission tunnel/drive shaft and the transfer case to front axle differential (indicated parts).

**i** The electrical wiring harnesses **must not** be in contact with the transfer case to front axle differential.

- a. Electrical wiring harness is in contact with indicated parts but is **not damaged**: Carry out **Work Procedure 1**.
- b. Electrical wiring harness is in contact with indicated parts and **is damaged**: Carry out **Work Procedure 2**:  
**Work Procedure 2a:** Only protective sheathing is damaged.  
**Work Procedure 2b:** Signal lines (Figure 1, B) are damaged.
- c. Electrical **power supply line** (Figure 1, A) (line cross-section **10 mm<sup>2</sup>**) **is damaged**: Carry out **Work Procedure 3**.
- d. Electrical wiring harness is **routed correctly**: **End Measure**.

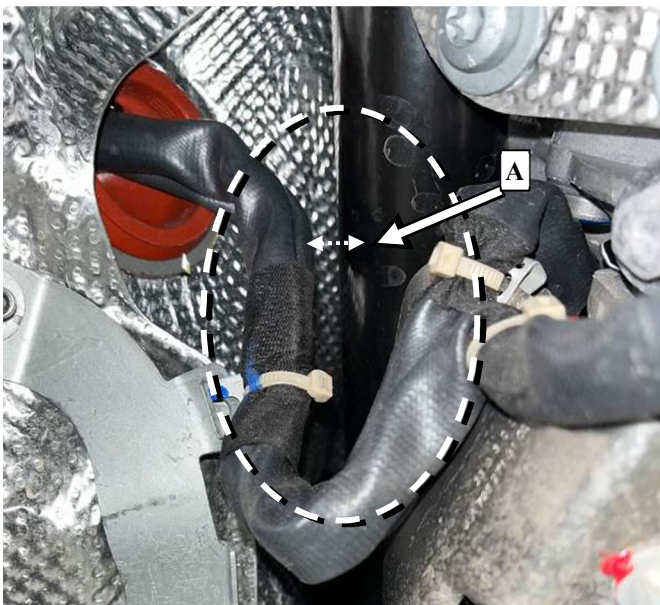
Figure 2

**i** The distance between the electrical wiring harness and the drive shaft **must be** at least **10 mm (Figure 2, A)**.

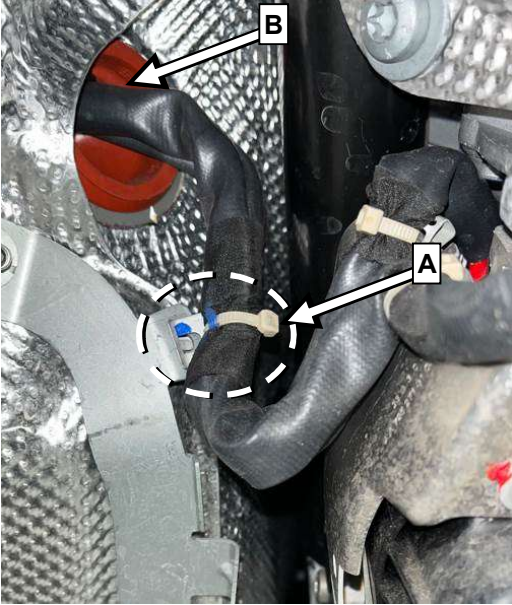
**Figure 3**

**i** Electrical wiring harness is in contact with indicated parts but is **not damaged**.

1. Cut cable tie at first clip (**Figure 3, A**).

2. Adjust length of electrical wiring harnesses between red grommet (**Figure 3, B**) and first clip (**Figure 3, A**) as shown.
  - i** The length must be between **90 mm and max 100 mm** from the first clip (**Figure 3, A**) to the red grommet.
  - i** The electrical wiring harnesses **must not be** in contact with indicated parts.
3. Fasten both electrical wiring harnesses to first clip (**Figure 3, A**) with a new cable tie.
  - i** The electrical wiring harness **must not be** in contact with indicated parts in **any location**.

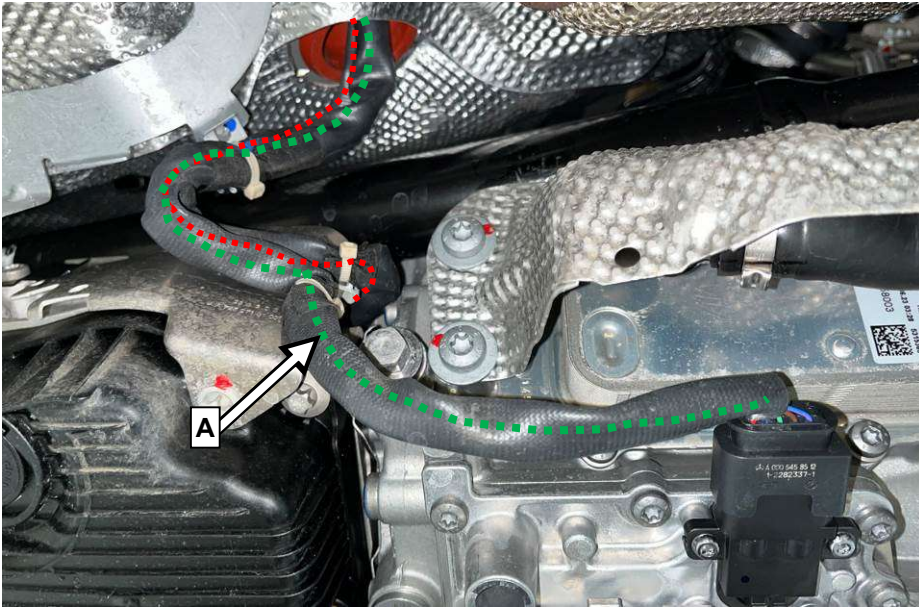
**Figure 4**

- i** Electrical wiring harness is in contact with indicated parts and ***is damaged*** (chafing, melting, tears/scoring).  
**i** **If only the protective sheathing is damaged, and the electrical harness wiring has no signs of damage:**

- i** One or more of the electrical signal lines (**line cross section 0.35 mm<sup>2</sup> to 0.75 mm<sup>2</sup>**) in the electrical wiring harness (**Figure 4, A**) shows signs of damage.

1. Wrap affected area with fabric tape.
2. Route electrical wiring harness (**Figure 4, A**) correctly as shown  
**i** The electrical wiring harness (**Figure 4, A**) must not be in contact with indicated parts ***in any location***.

1. Remove rear section of underfloor paneling.  
**i** For basic information, see **AR61.30-P-1001WT**.
2. Repair the respective affected electrical signal line (**line cross section 0.35 mm<sup>2</sup> to 0.75 mm<sup>2</sup>**) in the electrical wiring harness (**Figure 4, A**) using a line connector.  
**i** For basic information, see **AR00.19-P-0100A**.  
**i** To do this, cut the protective sheathing, repair wire harness using a line connector, and reinstall the protective sheathing using fabric tape to connect the cut sides.
3. Route electrical wiring harness (**Figure 4, A**) correctly as shown.  
**i** The electrical wiring harness (**Figure 4, A**) ***must not be*** in contact with indicated parts ***in any location***.
4. Assemble in reverse order.

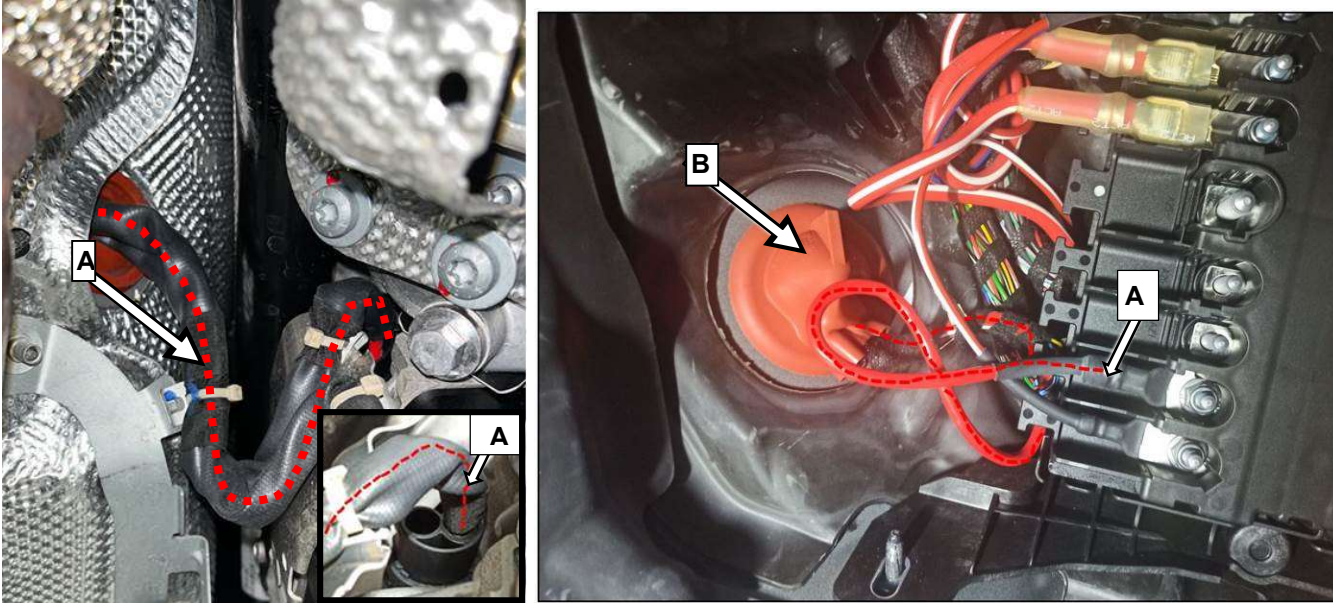
Figure 5

**i** If the electrical power supply line (Figure 5, A) (line cross section 10 mm<sup>2</sup>) is damaged, replace electrical power supply line (Figure 5, A):

1. Disconnect ground line of 12 V on-board electrical system battery.  
**i** For basic information, see **AR54.10-P-0051WT**.
2. Remove rear section of underfloor paneling.  
**i** For basic information, see **AR61.30-P-1001WT**.
3. Remove protective metal sheet (Figure 6, A).
4. Disconnect electrical power supply line (Figure 5, A) from electrical connector at transmission.
5. Remove front floor covering at front passenger side.  
**i** For basic information, see **AR68.80-P-0008WT**.
6. Remove electrical power supply line (Figure 5, A) with grommet (Figure 5, B).
7. Replace electrical power supply line (Figure 5, A).  
**i** The electrical wiring harness **must not** be in contact with indicated parts at **any location**.
8. Assemble in reverse order.
