TO: Mercedes-Benz Dealer Principals, General Managers, Sales Managers, Service Managers, Parts Managers	FROM: Anthony Washington, Senior Manager, Regulations and Certifications
Re: Launch Recall Campaign Notification Model: Sprinter Model Year: 2023 Inspect Quick Connect Ground Connection	DATE: April, 2024

IMPORTANT RECALL CAMPAIGN INFORMATION

Campaign No. :	Campaign Desc. :	Inspect Quick Connect Ground Connection
2024030020	VS3HVERSL	
<p>This is to notify you of a Recall Campaign launch to inspect the quick connect ground connection on approximately 99 MY 2023 Mercedes-Benz Sprinter Vans. The recall campaign will be visible on the www.safercar.gov website and may generate questions from customers. All affected VINs will be flagged as "OPEN" in VMI and cannot be sold until remedied.</p>		
Background		
Issue	<p>Mercedes-Benz AG ("MBAG"), the manufacturer of Mercedes-Benz Sprinter vehicles, has determined that on certain Sprinter vans (907 platform), the 12V ground connection quick-release fastener might not be fastened properly. In this case, the quick-release fastener might loosen over time and may cause the electrical resistance on this connection to increase. As a result, the t

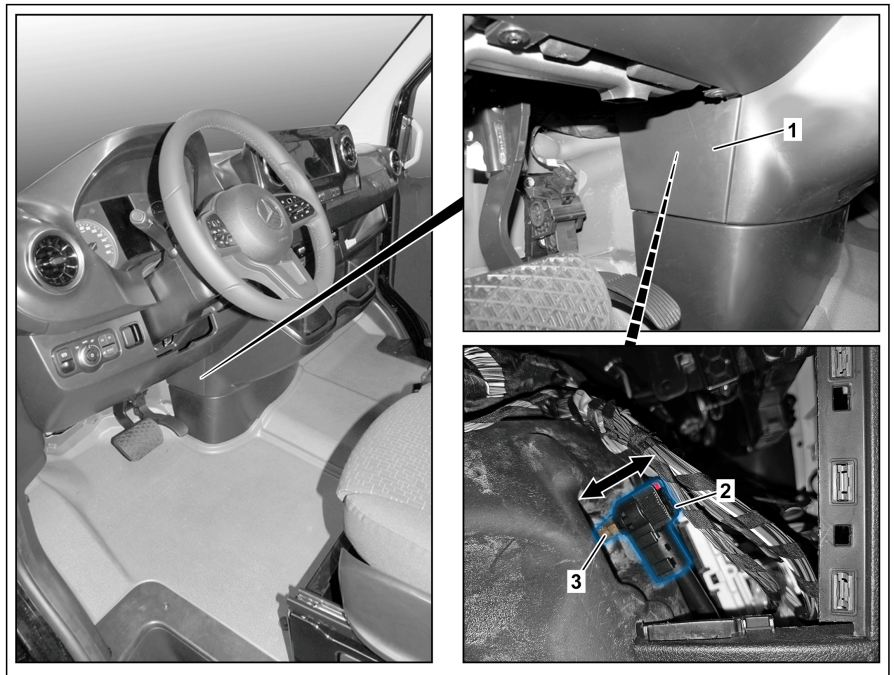
D54.10-A113-76

- 1 *Cover*
- 2 *Electrical connector (main switch)*
- 3 *Ground connection*

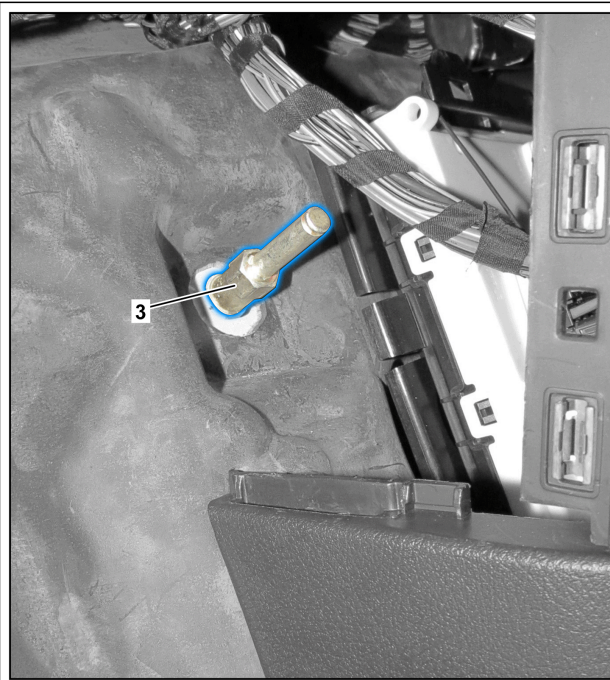
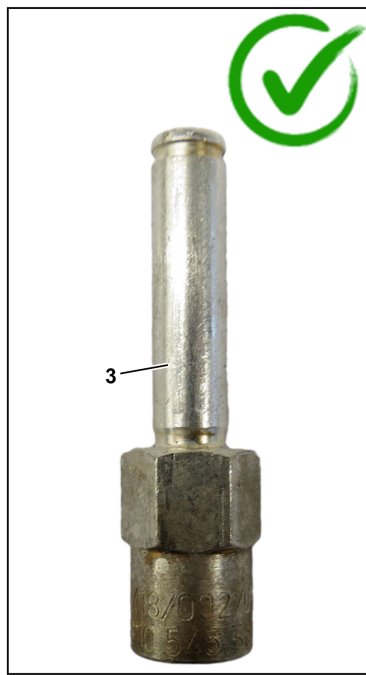
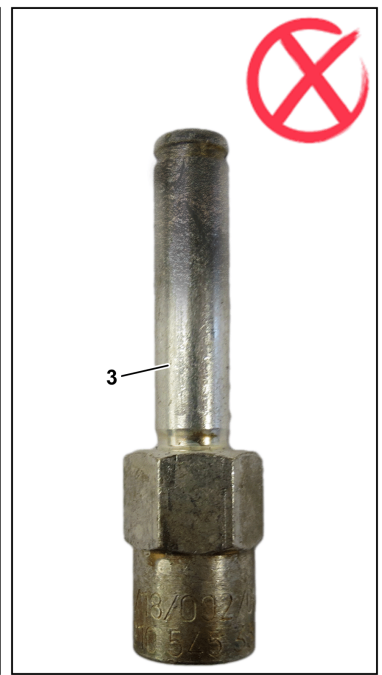
D54.10-A112-79

3 Ground connection

6	Check electrical connector (2) and ground connection (3) for thermal damage.	<p>If traces of soot are present on the electrical connector (2) or ground connection (3),</p> <p style="text-align: center;">↓</p> <p>Replace wiring harness (ground line) and ground connection (3); to do so, continue with operation step 8.</p> <p>If there are no traces of soot on the electrical connector (2) or ground connection (3),</p> <p style="text-align: center;">↓</p> <p>continue with operation step 10.</p>	
	Replace		
7	Replace ground connection (3).	<p>If thermal damage is present.</p> <p>

Contact pin to body ground point</p>	BA54.10-Z-1007-01KTS
8	Replace wiring harness .	If thermal damage is present.	AR54.10-D-0002TS

Check		
10	Check electrical connector (2) for correct locking.	<p>

</p> <p>To do so, attempt to disconnect the electrical connector (2) from the ground connection (3) without actuating the release.</p>
