## **Subarunet Announcement**

### **UPDATE Safety Recall: WRA-24 ODS Sensor Replacement**

Subaru of America, Inc. (Subaru) has initiated a safety recall for certain 2020-2022 model year Legacy and Outback vehicles to replace all (four) of the Occupant Detection System (ODS) sensors on the front passenger seat.

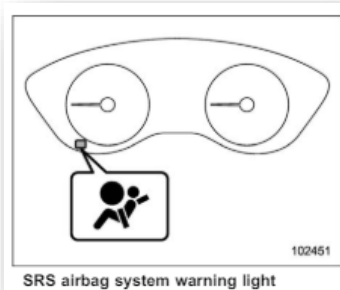
If the supplemental restraint system (SRS) airbag system warning light is illuminated in your instrument panel, your vehicle may be experiencing symptoms related to this safety recall. Please contact your authorized Subaru retailer for further diagnosis and refrain from allowing passengers in the front passenger seat until the diagnosis is complete.
