TO: Mercedes-Benz Dealer Principals, General Managers, Sales Managers, Service Managers, Parts Managers	FROM: Gregory Gunther, Senior Manager, Vehicle Compliance and Analysis, Engineering Services
RE: Recall Campaign Launch Notification STOP DRIVE Inspect and Replace Brake Booster with Pedal Rework MY06-12 GL-Class, ML-Class, R-Class (164 and 251 platform)	DATE: May 10, 2024

Campaign No. 2024050002, May 2024

SUBJECT: **Model GL-Class, ML-Class, and R-Class (X164, W164 and 251 platform)
Model Year 2006 – 2012**

Inspect Brake Booster – with Pedal Rework

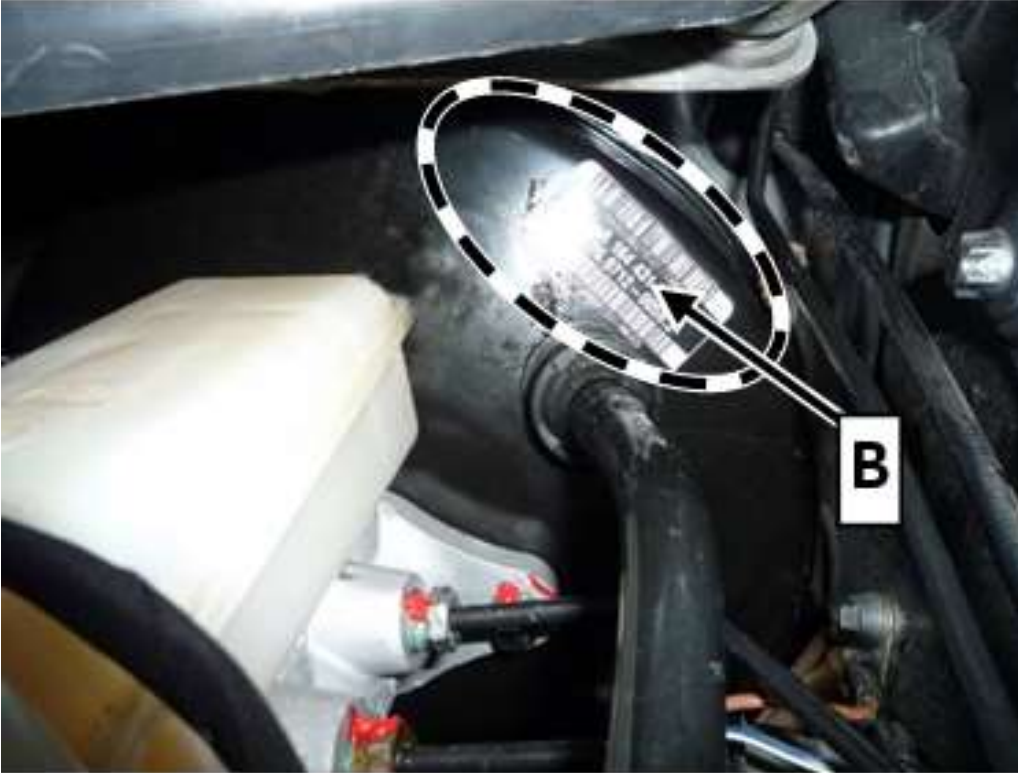
Figure 8

1. Take a photo of the barcode label (**Figure 8, B**) on the brake booster and store to a local HDD/computer storage location with the vehicle service file and attach to the warranty claim in EVA.

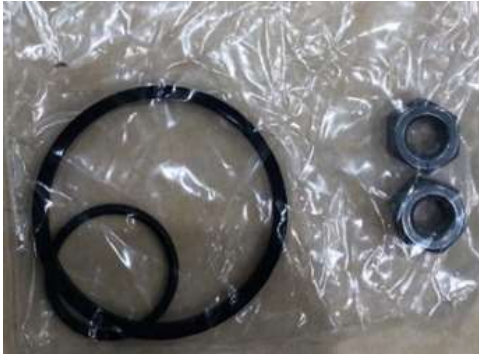
Figure 12

i The new brake booster contains a small parts kit (**Figure 12**).

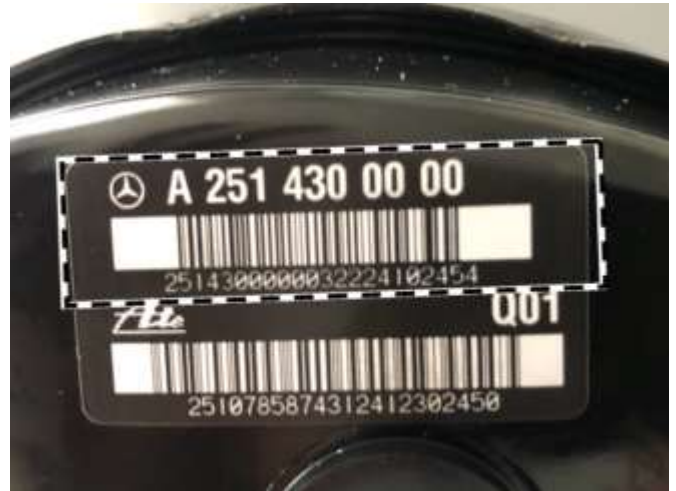
Figure 13

5. Read out serial number (**Figure 13**) using the **Mercedes-Benz PartScan** app.
