| RE: <b>Recall Campaign Launch Notification STOP DRIVE</b><br><b>Inspect and Replace Brake Booster without Pedal Rework</b><br><b>MY06-12 GL-Class, ML-Class, R-Class</b><br><b>(164 and 251 platform)</b> | DATE: May 10, 2024 |

**Inspect and Replace Brake Booster Without Pedal Rework**

Campaign No. 2024050001, May 2024

## **Inspect Brake Booster – without Pedal Rework**

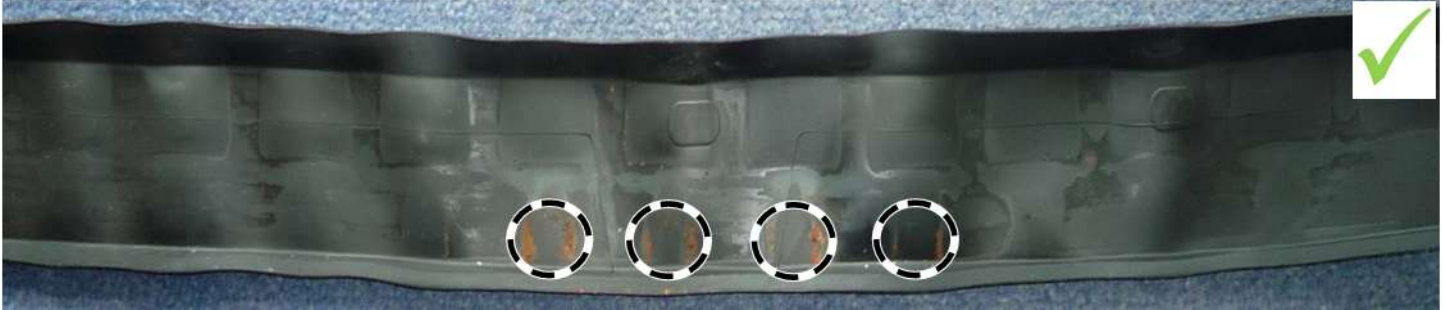
Figure 5 (OK)

Multiple point-shaped corrosion marks (Figure 5) are permissible.

**i** If the measure is ended, **do not** re-install a rubber sleeve. Apply marking with **white touch-up paint pen** (Figure 10, 1) to the brake booster checked.

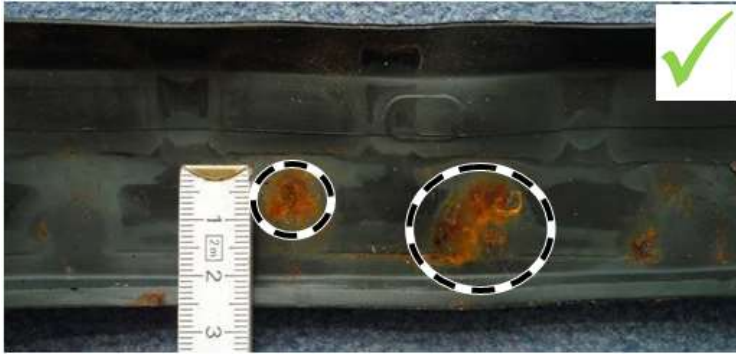
Figure 6 (OK)

A maximum of **one point-shaped corrosion mark** with a diameter **greater than 15 mm** (Figures 6 and 7) is permitted.
