# Recall Campaign Bulletin

Campaign No. 2024060009, June 2024

SUBJECT: **Model C-Class (206 platform)**  
**Model Year 2023**

## **Check AMG Performance Seat Wiring Harness Routing**

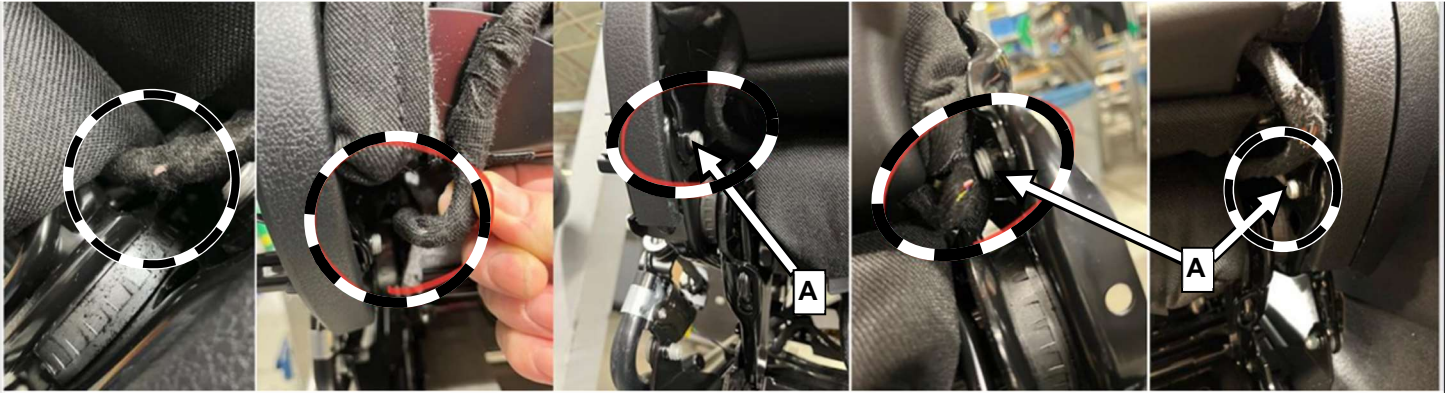
3. Check the seat wiring harness routing on the left side of driver seat and the right of front passenger seat (outboard sides) in the area of the backrest hinge screw (Figure 3, A):

Figure 3 – NOT OK condition, shown on left and right front seats

- a. The seat wiring harness *is* damaged (Figure 3): Perform **Work Procedures A and B**.
- b. The seat wiring harness *is not* damaged: Perform **Work Procedure B**.

1. If the seat wiring harness is **damaged**, remove the corresponding seat and repair the wiring harness.
  - i** Remove/install the front seat (AR91.10-P-1000WT) and repair the wiring harness (AR00.19-P-0100-09A).

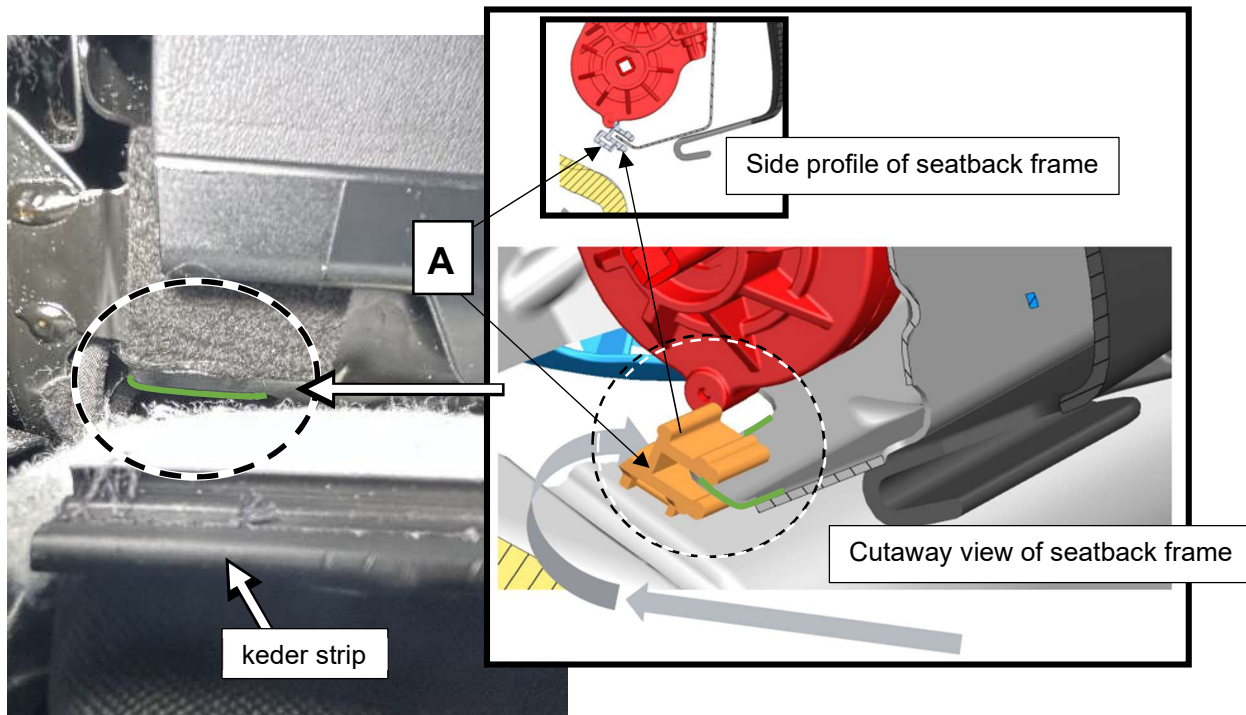
Figure 5 – fastening clip is secured to sheet metal area without felt (Figure 5, green outline).

1. Attach a cable tie with fastening clip to secure the wiring harness to the seat backrest frame. The seat backrest frame sheet metal has felt applied, and a section measuring 2-3mm **without felt** (Figure 5, green outline). Attach the fastening clip (Figure 5, A) flush to the outer edge of the sheet metal without felt and secure it flush against the sheet metal in the direction shown (Figure 5 and 6).

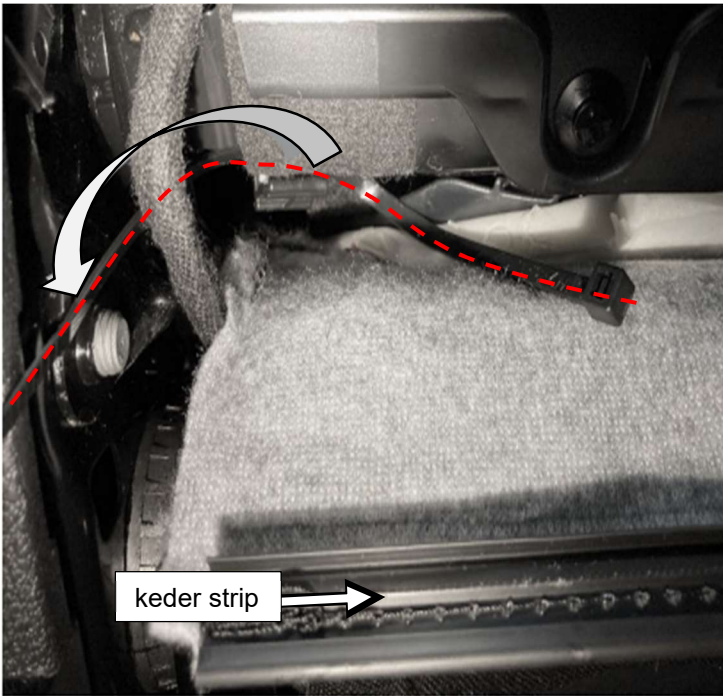
Figure 6 – cable tie routed through fastening clip eyelet.

**NOTE:** The cable tie (Figure 6, red dashed line) is routed behind the seat backrest frame, through the eyelet of the fastening clip (Figure 5, A), and around the seat wiring harness to secure it from damage.
