IMPORTANT RECALL CAMPAIGN UPDATE

Recall Campaign Launch Notification			June 15, 2024		
Campaign No.:	NHTSA ID	Campaign Desc. :	Update Battery Management		
2024060002	24V372	24P5496226	System Software – Wave 2		
This is to notify you of the Recall Campaign Launch to update the Battery management System software on <u>15,351</u> Model Year ("MY") 2023-2025 EQE and EQS (294, 295, 296, and 297 platform) vehicles. The recall campaign will be visible on the www.NHTSA.gov website and may generate questions from customers. <u>13,351</u> Affected VINs were flagged in VMI as "OPEN" on <u>June 7, 2024</u> . An Additional <u>1,378</u> affected VINs will be flagged as "OPEN" on <u>June 15, 2024</u> .					
		Backgrou			
Mercedes-Benz AG, the manufacturer of Mercedes-Benz vehicles, has determined to MY 2023-2025 EQE (294 and 295 platform) and EQS (296 and 297 platform) monitoring software of the Battery Management System ("BMS") might not production specifications and may lead to a shutdown of the high-voltage system situations. The contactors of the high-voltage battery might open, potentially resulting propulsion without warning. As a consequence, the risk of a crash might increase. When comes

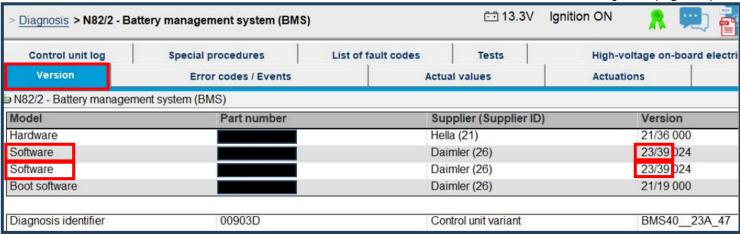
Figure 1

NOTE: To confirm the BMS software, the Software Version will read "23/XX" or newer in XENTRY Diagnosis (Figure 1).
