TO: Mercedes-Benz Dealer Principals, General Managers, Sales Managers, Service Managers, Parts Managers	FROM: Gregory Gunther, Senior Manager, Vehicle Compliance and Analysis, Engineering Services
RE: Recall Campaign Launch Notification Update Battery Management System Software – Wave 1 MY23-25 EQE and EQS (294, 295, 296, and 297)	DATE: June 7, 2024

Campaign No. 2024060002, June 2024

SUBJECT: **Model EQE and EQS (294, 295, 296, and 297 platform)**
Model Year 2023 – 2025

Update Battery Management System Software – Wave 1

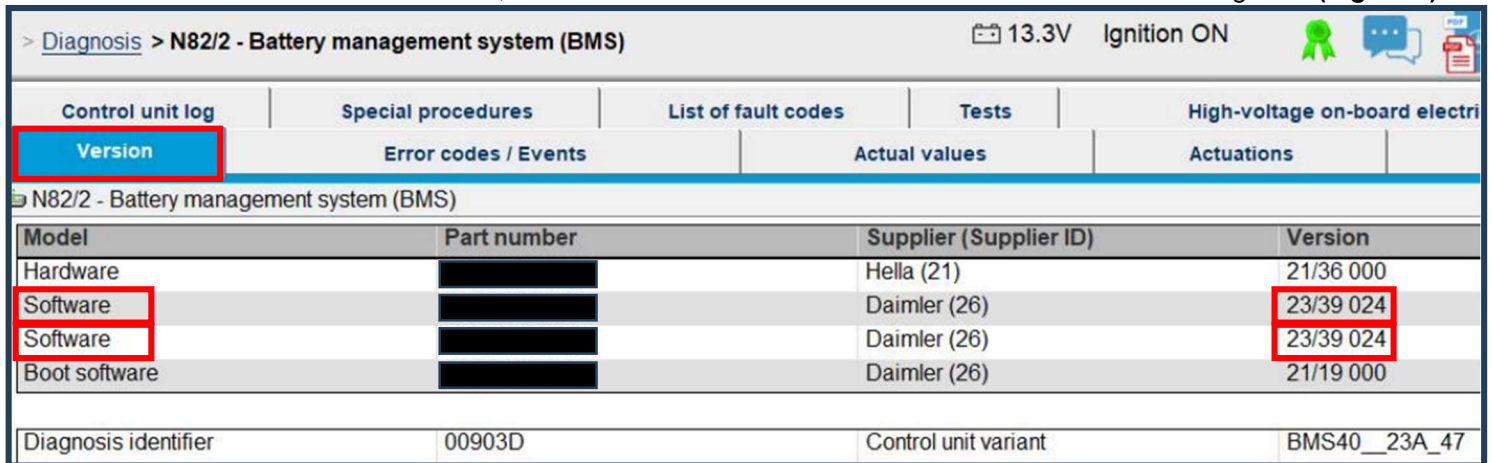
Figure 1

NOTE: To confirm the new BMS software, the Software **Version** will read "**23/XX XXX**" in XENTRY Diagnosis (**Figure 1**).

1. Connect XENTRY Diagnosis.
2. Update **Battery Management System (BMS)** control unit software.
 - i** To do this, select menu item "Quick test view – N82/2 Battery management system (BMS) – Adaptations – Control unit update – Update of control unit software".
 - i** Then follow the user guidance in XENTRY Diagnosis.
