TO: Mercedes-Benz Dealer Principals, General Managers, Sales Managers, Service Managers, Parts Managers	FROM: Gregory Gunther, Senior Manager, Vehicle Compliance and Analysis, Engineering Services
RE: Recall Campaign Launch Notification Update Battery Management System Software – Wave 1 MY23-25 EQE and EQS (294, 295, 296, and 297)	DATE: June 7, 2024

Campaign No. 2024060002, June 2024

SUBJECT: **Model EQE and EQS (294, 295, 296, and 297 platform)**
Model Year 2023 – 2025

Update Battery Management System Software – Wave 1

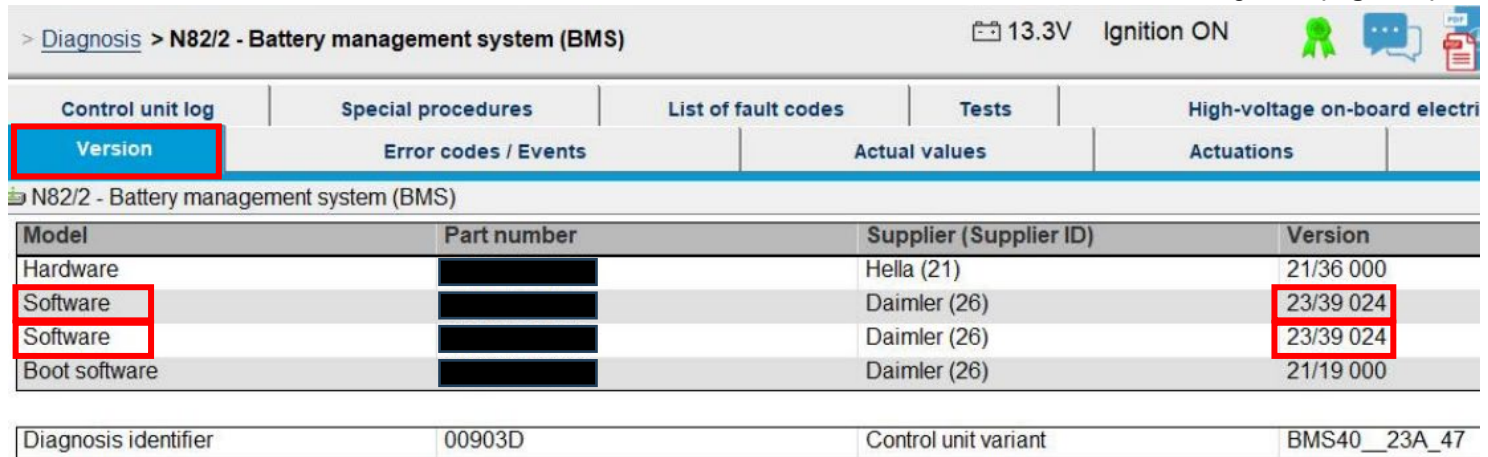
Figure 1

NOTE: To confirm the new BMS software, the Software **Version** will read "**23/XX XXX**" in XENTRY Diagnosis (**Figure 1**).

2. Update **Battery Management System (BMS)** control unit software.

i To do this, select menu item "Quick test view – N82/2 Battery management system (BMS) – Adaptations – Control unit update – Update of control unit software".
